IFB # 2019-047 Demolition Services at Roanoke County's Explore Park

ADDENDUM NO. 2

Asbestos Inspection Report at 3906 Rutrough Road

Asbestos Inspection Report

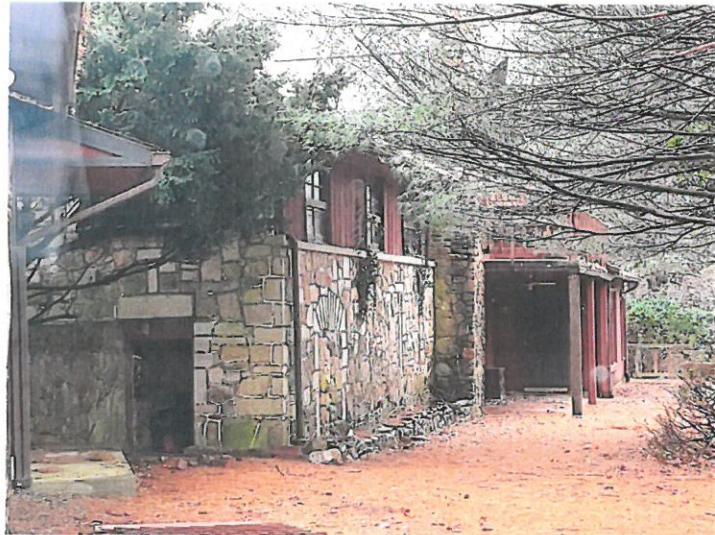
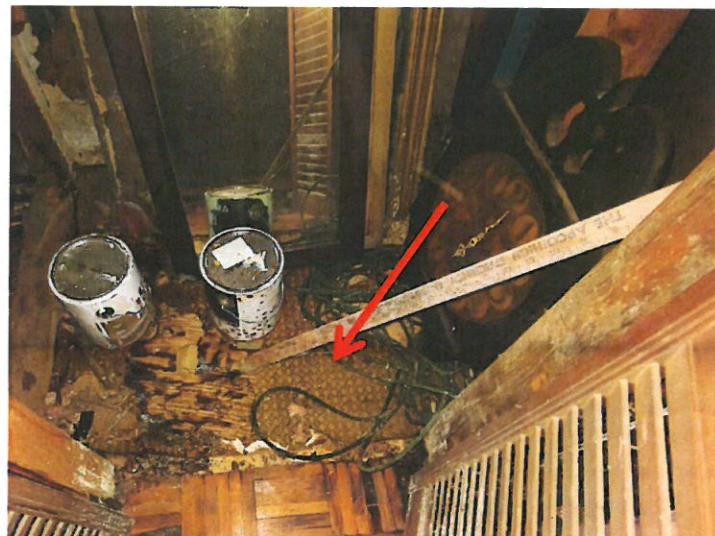
**The Linoleum located in the under stair closet was found to be
Asbestos Containing by the laboratory.**

These NON-Friable asbestos containing materials should be removed prior to demolition activities at this location. Removal should be performed by licensed, contract personnel using approved methods.

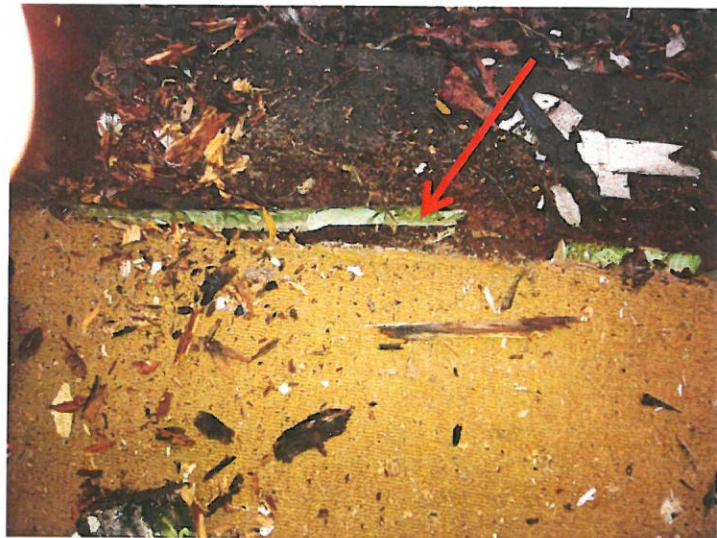
The Linoleum located in the rear workshop (Exterior Access Room) under carpet was found to be Asbestos Containing by the laboratory.

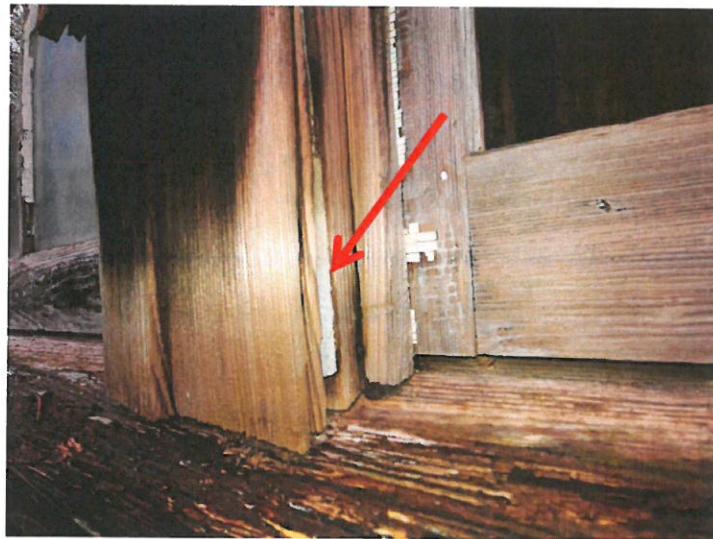
The Felt Paper located under wooden shingle siding on the shed behind the home was found to be Asbestos Containing by the laboratory.
