## REPORT OF SUBSURFACE EXPLORATION AND GEOTECHNICAL ANALYSIS

4354 TODDSBURY DRIVE SLOPE  
ROANOKE COUNTY, VIRGINIA

ECS REPORT NO. 12:8820-B

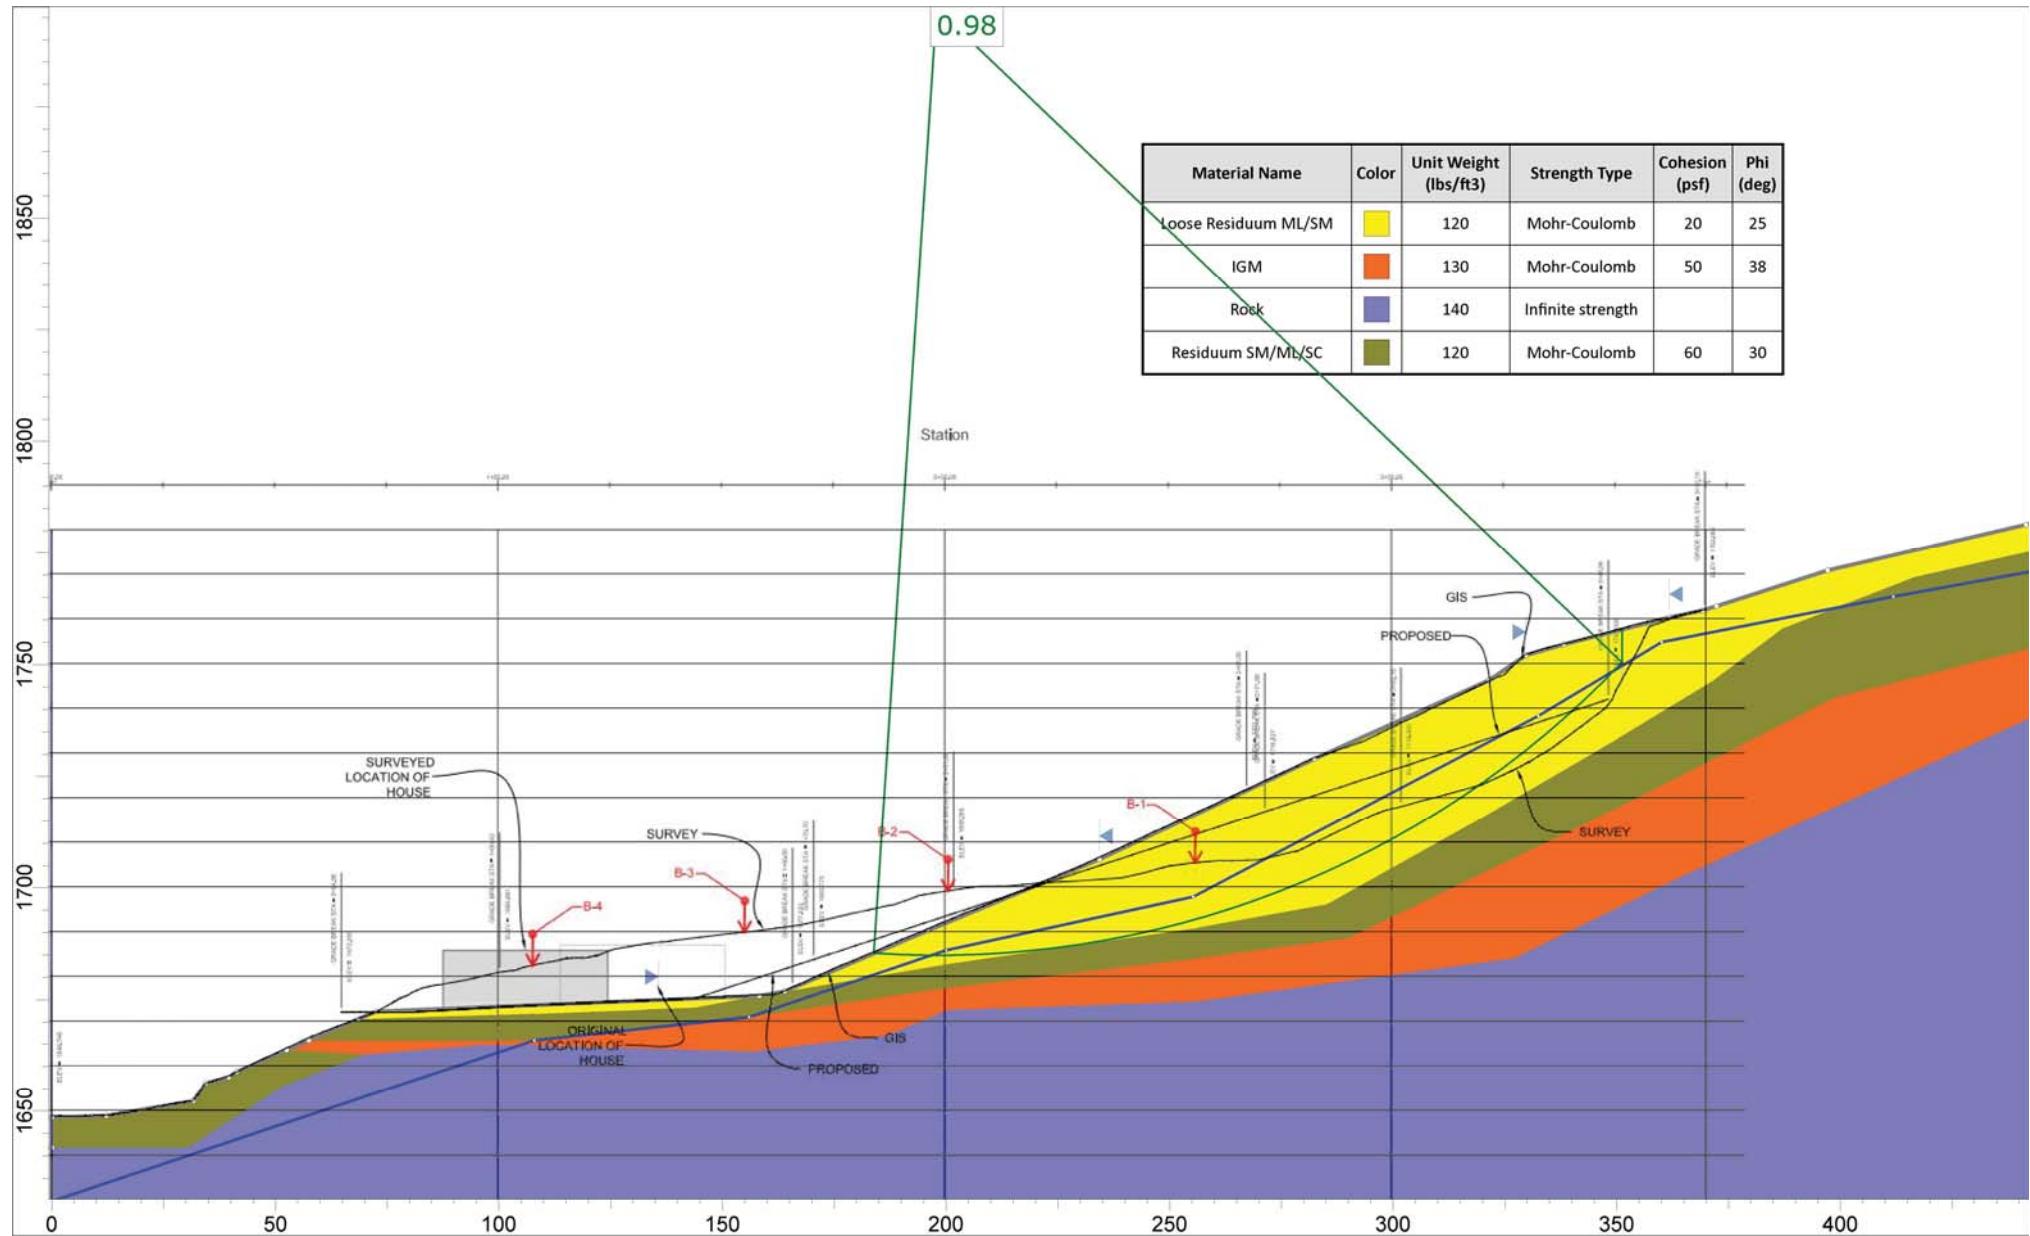
Analysis Description: Pre-Failure Condition Scenario

**Pre-Failure Condition Scenario:** The previous slope gradient conditions estimated from GIS data available from the County and depicted in the cross-section provide by CWA and included in the Appendix.

Based on the results of our soil borings and analysis for the pre-failure condition, a FS of less than 0.97 was estimated. In our opinion, the pre-failure condition was excessively steep for the soil type and groundwater regime noted in the temporary wells and evidence of seepage that would be expected to achieve a FS of 1.5 or greater. Moreover, we believe the pre-failure conditions progressively worsened due to multiple conditions during the life of the slope. Based on historical aerial photographs, the slope was excavated several years before construction of the house on the residence and had chronic problems with establishment of vegetation on the slope face. Due to poor stabilization of the slope face, we anticipate that progressive surface failures occurred over time allowing for deep infiltration of water into the slope face through tension cracks and weakened zones at escarpments. Prior to catastrophic failure of the slope,

the property owner reportedly regraded the slope face with loose material, although an escarpment near the crest was not sealed from moisture intrusion. The regrading reportedly also included removal of a significant volume of soils from the slope face, also steepening the slope face. This would result in further decrease in the FS for the modeling pre-failure condition. These progressively worsening conditions, coupled with significant precipitation over a prolonged period of time, resulted in the catastrophic period. However, based on our borings and analysis, the failure occurred as a wedge along the slope face, but deep seated failure does not appear to have occurred beyond the toe of the original slope.

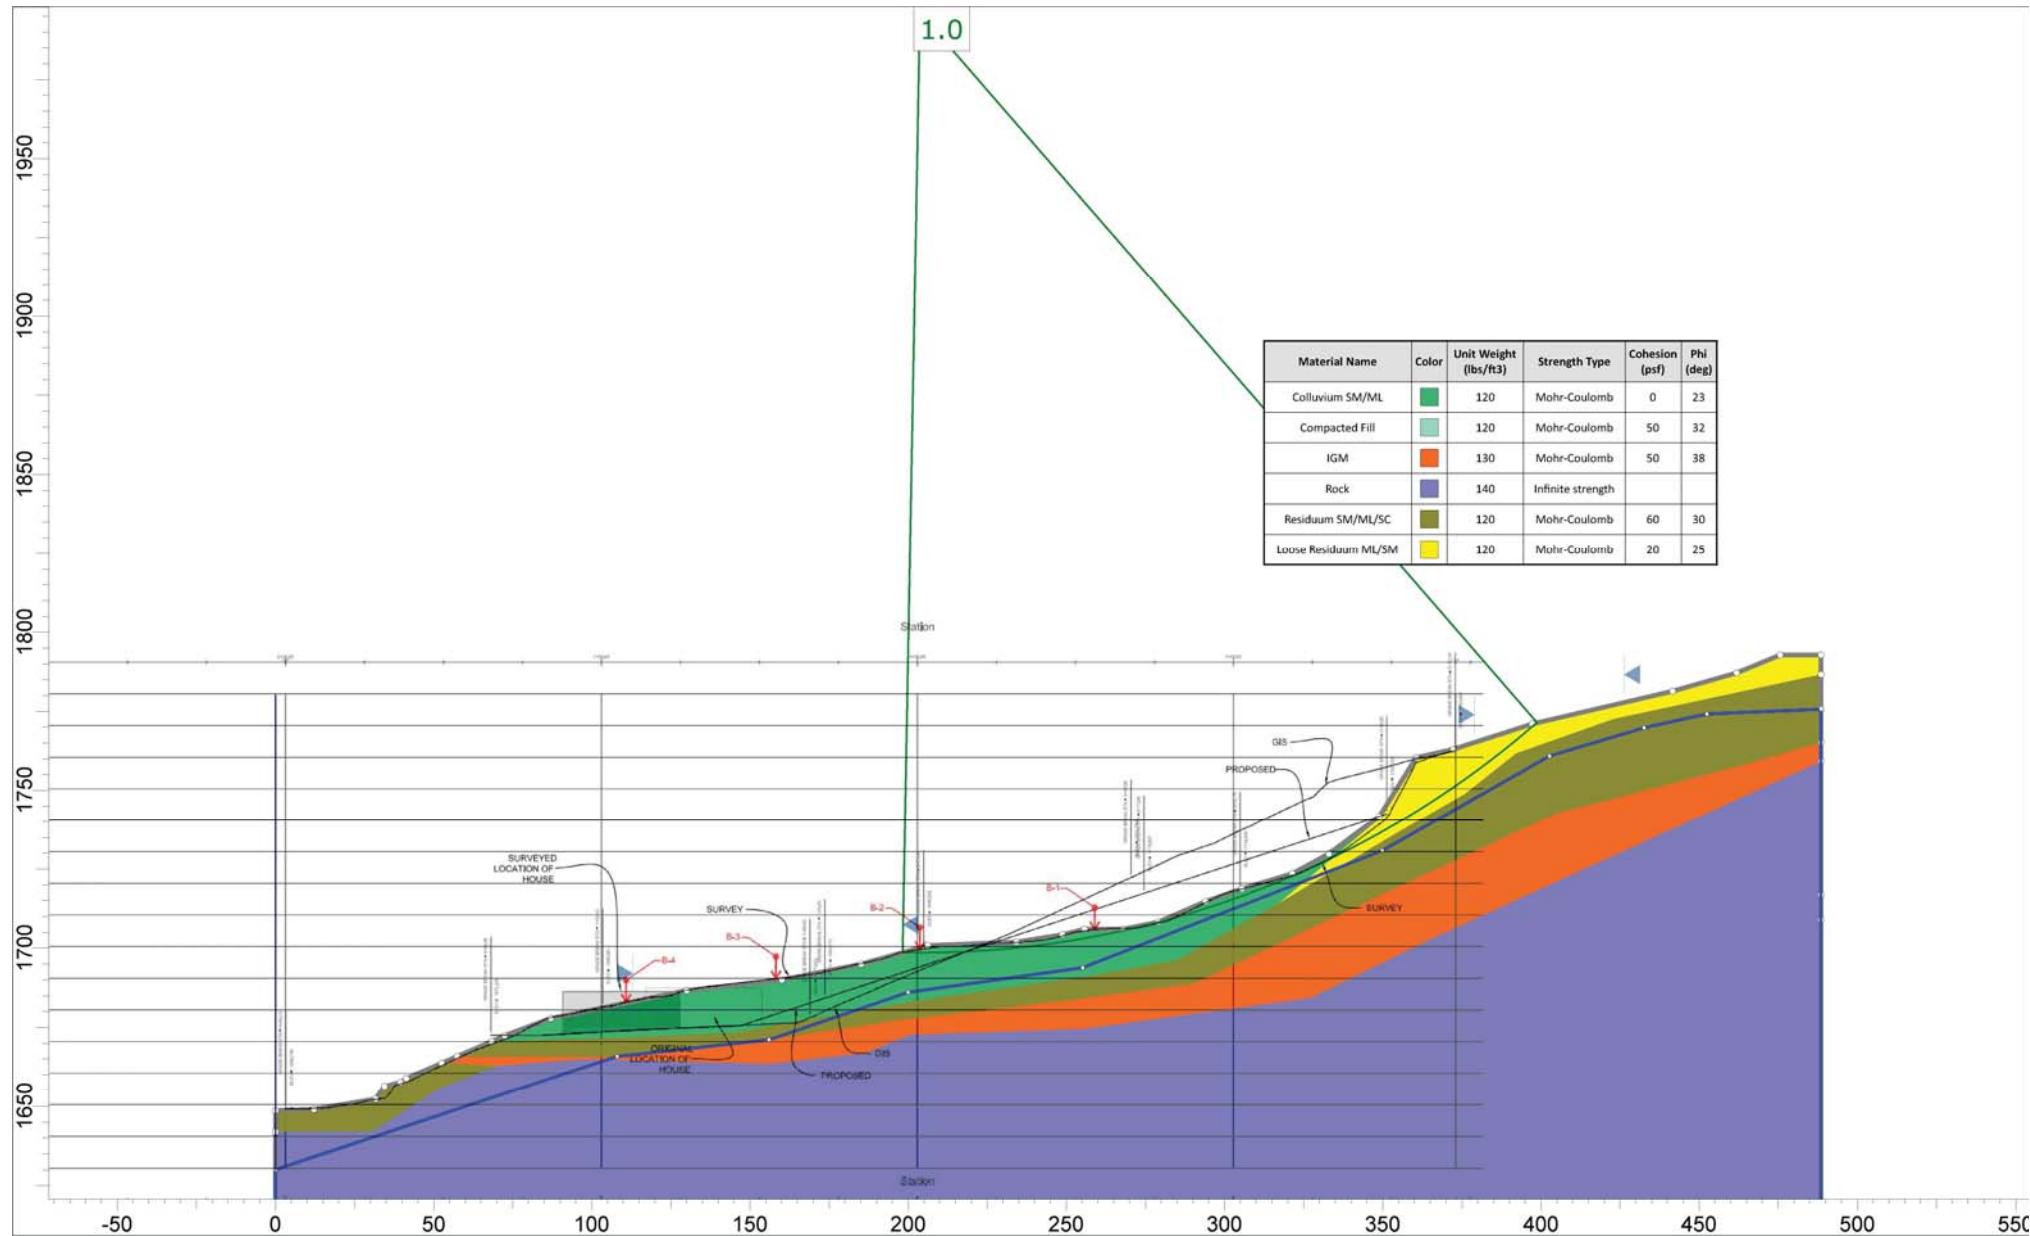
SLIDEINTERPRET 8.021	Project	Toddsbury Drive Slope Exploration		
	Analysis Description	Failure Condition Scenario		
	Drawn By	B.Quinn	Scale	1:729
	Date	2/19/2019		File Name
		Failure Section - Circular.slmd

**Failure Condition Scenario:** Analysis was performed based on the current slope condition, based on topographic data surveyed by CWA and depicted in the cross-section.

Our analysis of the current failed condition indicates a global FS of 1.0. In our opinion, the global stability results present excessive risk of future slope failure which could negatively impact adjacent properties.

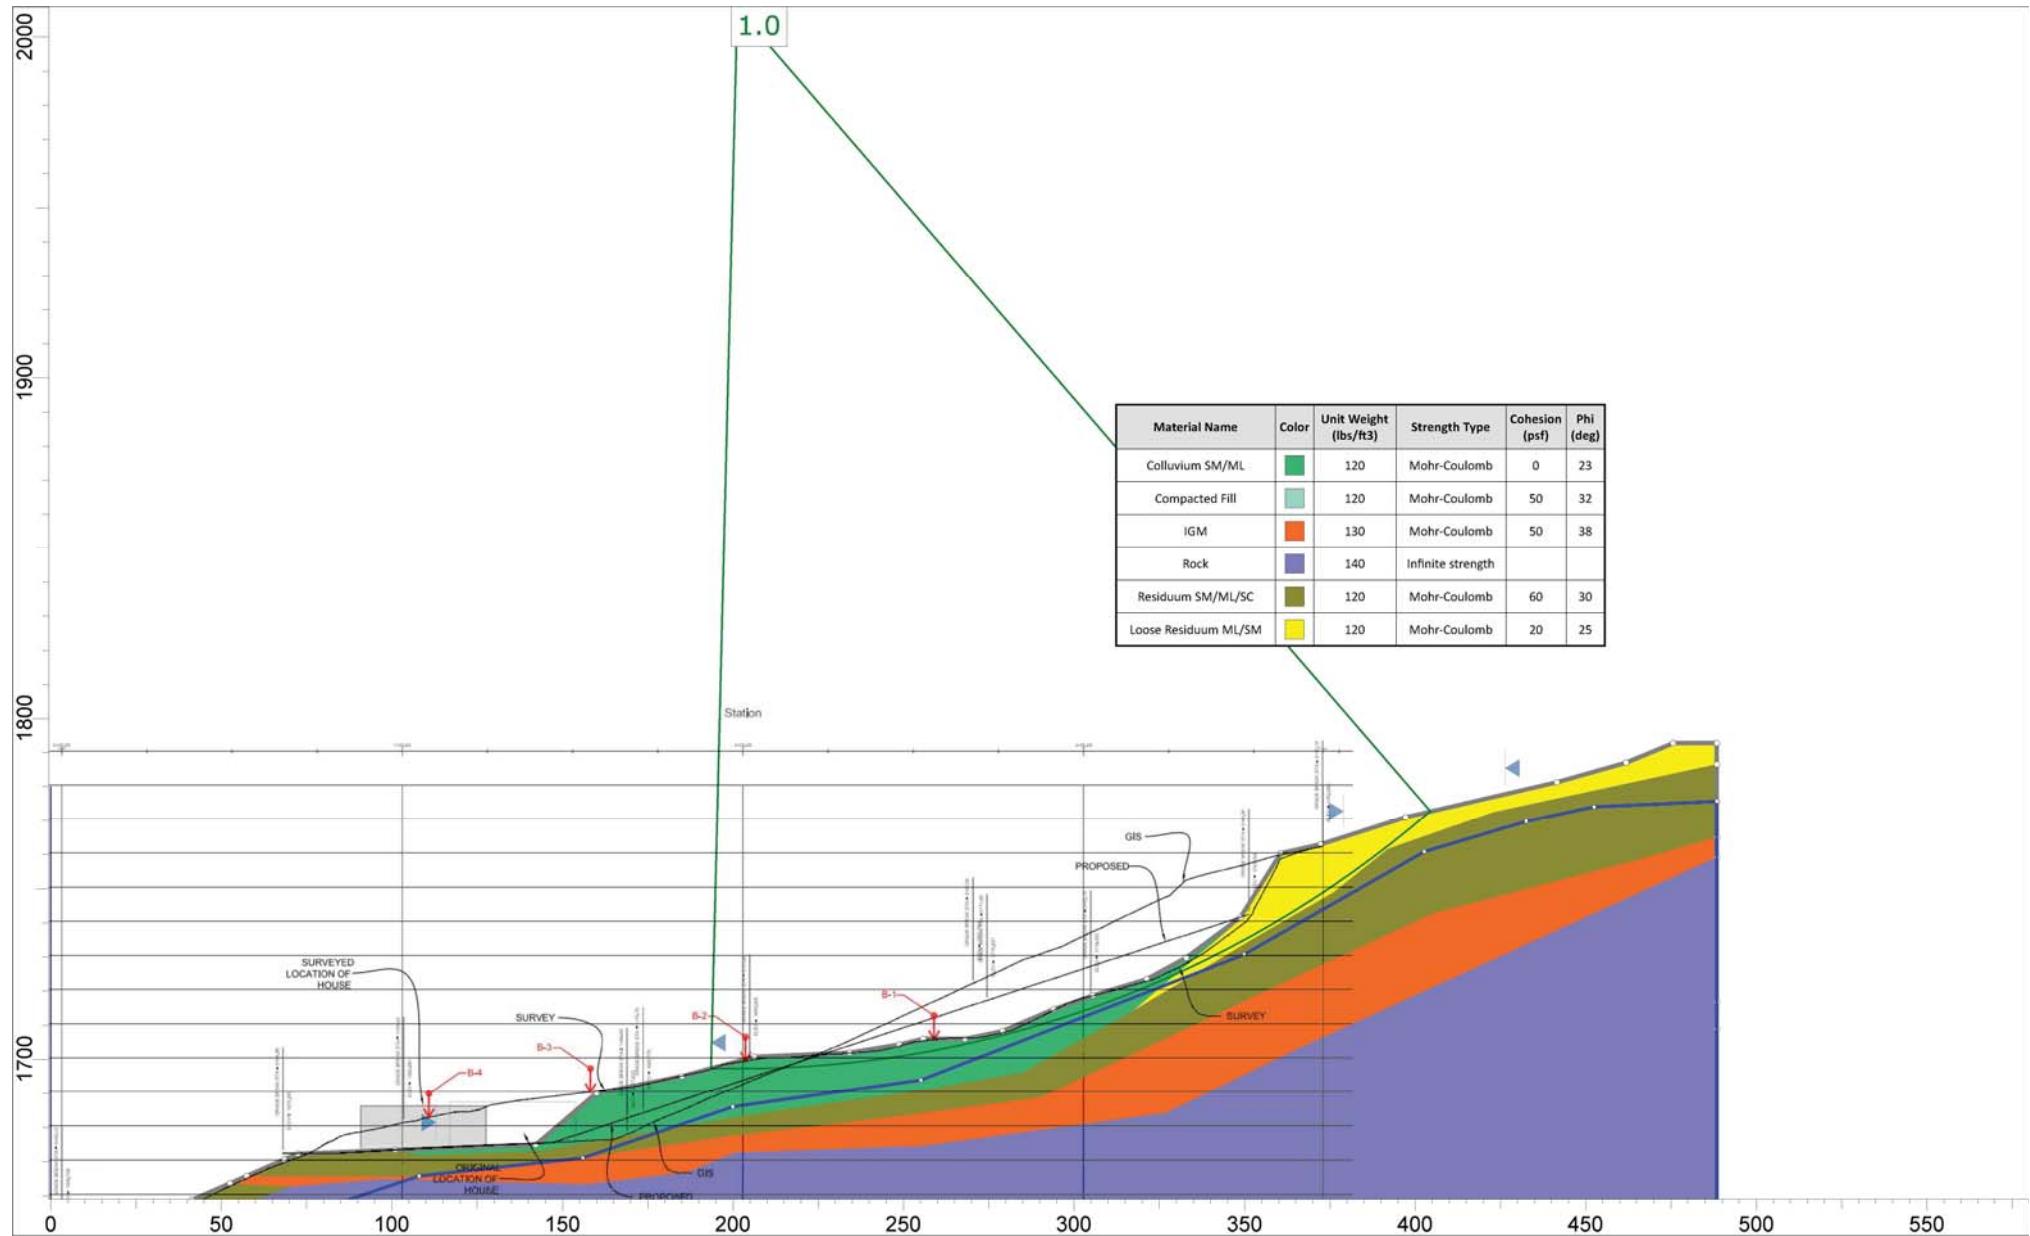
**Analysis Description:** Temporary Demolition Slope Scenario

**Temporary Demolition Slope Scenario:** Analysis was performed based on the failed condition cross-section, modified to demonstrate temporary removal of the colluvial deposits surrounding the house to permit for demolition and removal of the house.

Global stability analysis including a temporary slope excavated approximately 15 feet north of the existing house, sufficient to allow for demolition activities, results in a FS of 1.0. The temporary excavation should only be allowed for a short period of time sufficiently long to allow for demolition, and then reconstruction of the slope should commence immediately. The excavation should be performed in accordance with OSHA requirements assuming loose soils with seepage conditions.

Based on the noted goals of the County, we recommend that a temporary excavation be performed as noted above in order to allow for demolition of the house, followed immediately by construction of a 3H:1V slope up to the head scarp, placed over the colluvium. More specific recommendations are provided below.

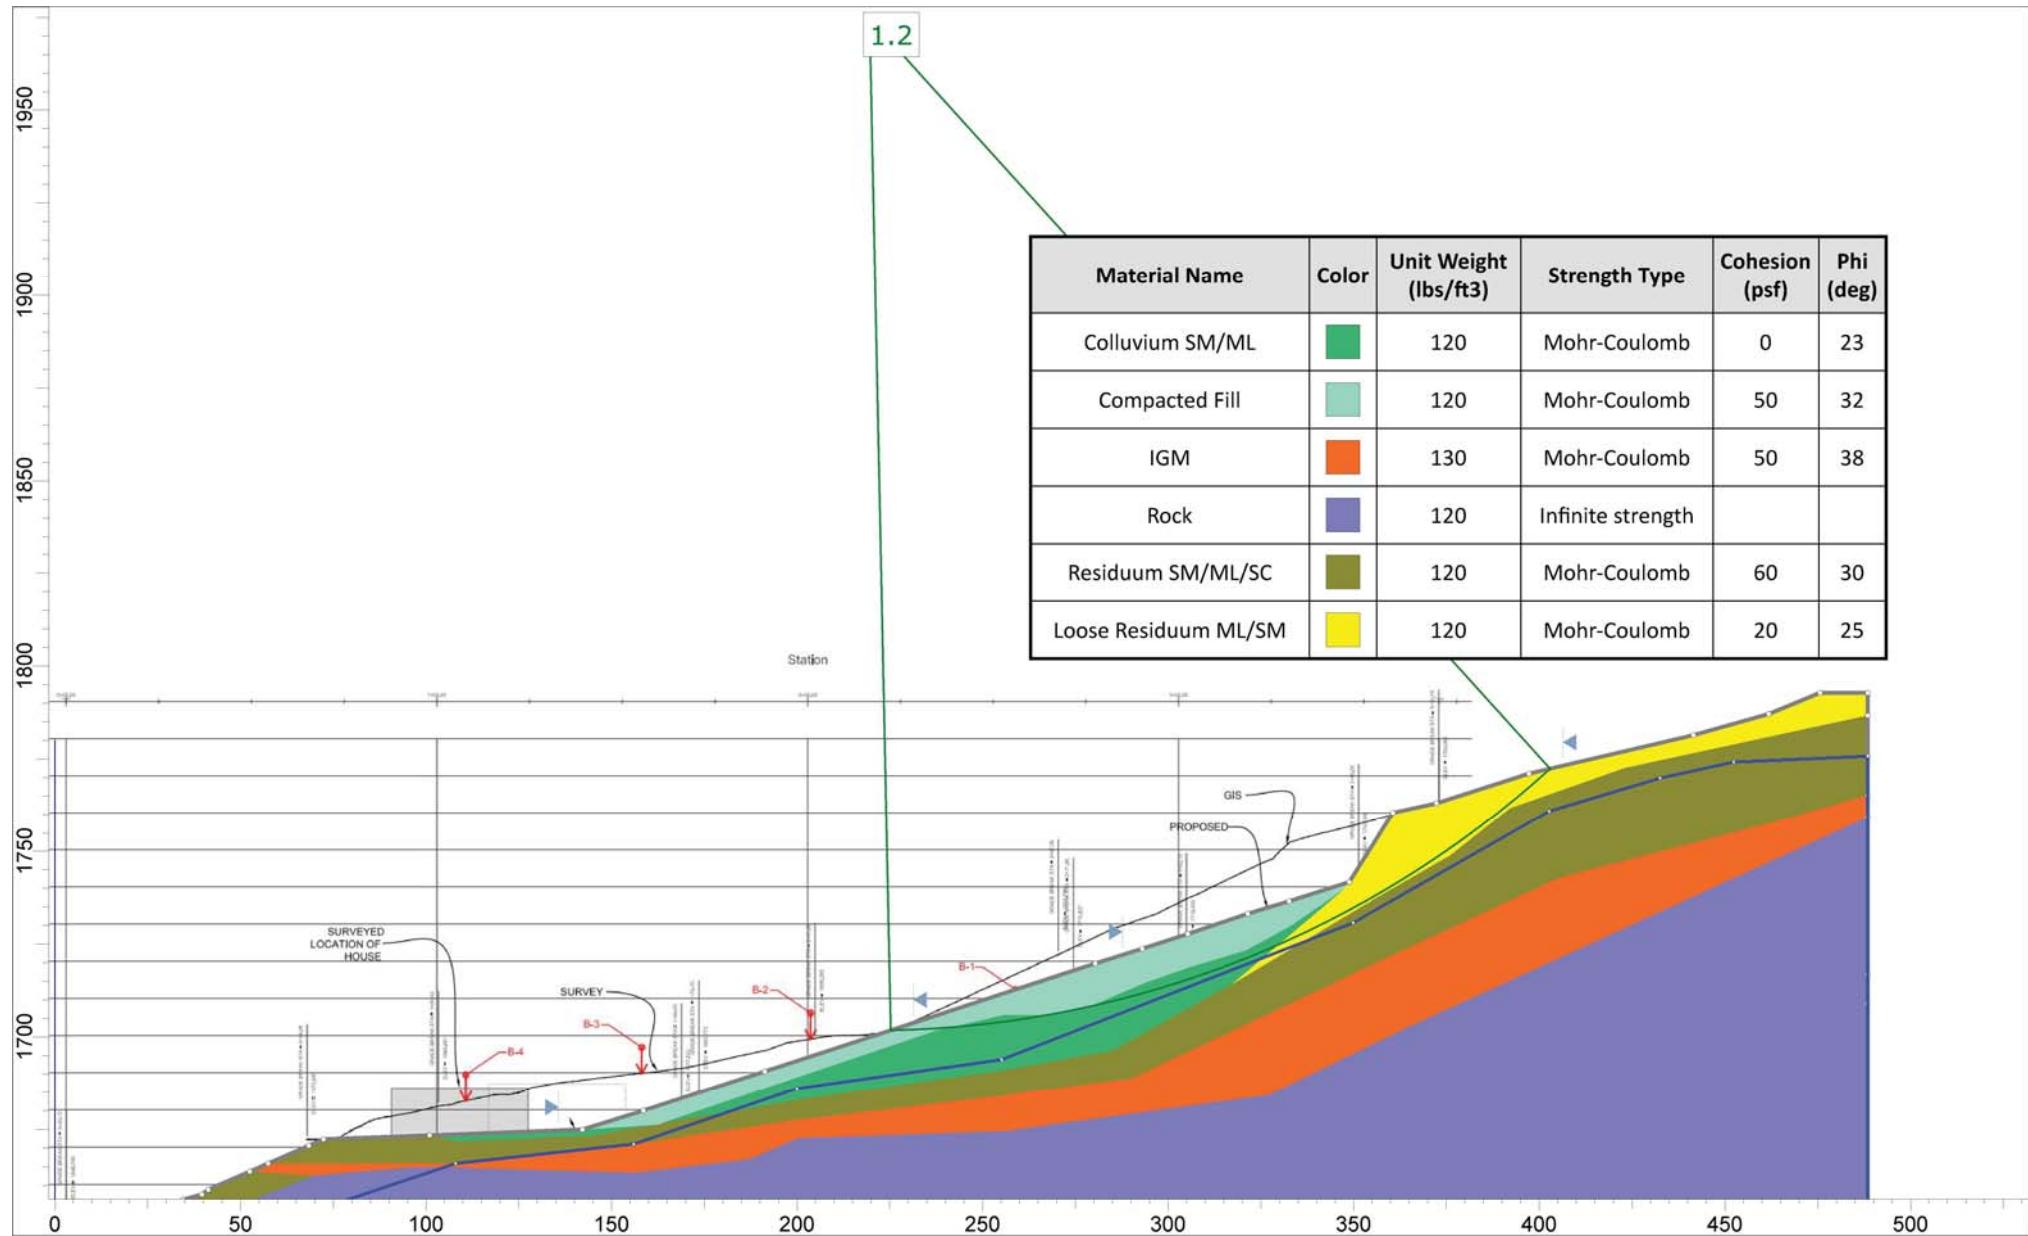
Analysis Description: Proposed Repair Condition Scenario

**Proposed Repair Condition Scenario:** Analysis was performed based on the proposed reconstructed 3H:1V slope, with fill placed directly over the colluvial deposits, provided by CWA and depicted in the cross-section.

Our analysis of the proposed regrading activities, with construction of a 3H:1V slope extending up to the head scarp, results in an estimated FS of 1.2, excluding failure through the head scarp. While the resulting FS does not indicate construction of a structure on the property is permissible, the proposed does not indicate unreasonable risk of future instability that would be expected to negatively impact neighboring properties. However, the recommendations for grading activities and stabilization provided in the section below should be followed.

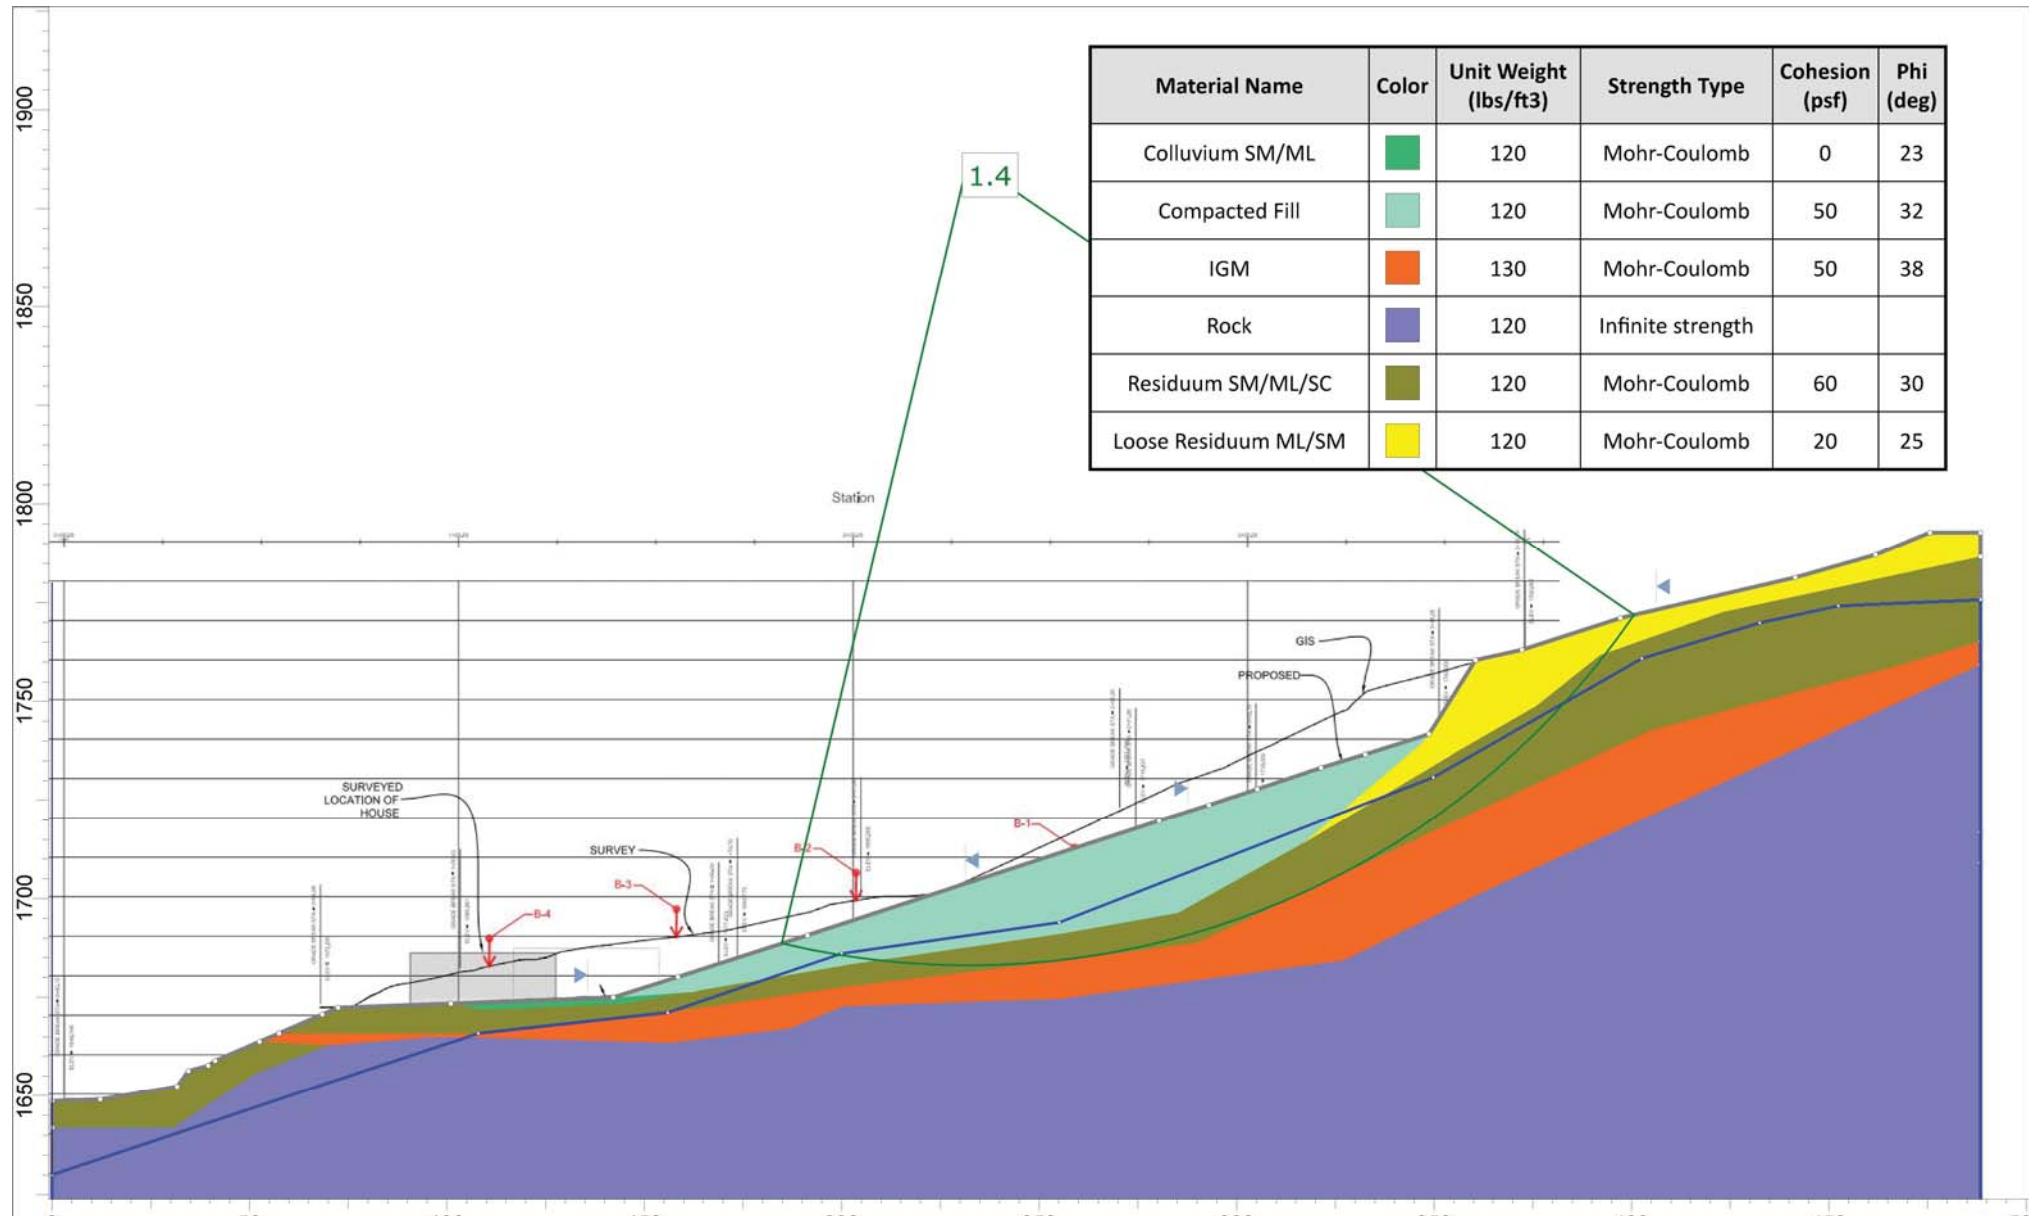
SLIDEINTERPRET 8.021	Project	Toddsbury Drive Slope Exploration		
	Analysis Description	Complete Colluvium Removal Scenario		
	Drawn By	B.Quinn	Scale	1:584
	Date	2/19/2019		Company
		ECS Mid-Atlantic		File Name

**Proposed Repair Condition with Replacement of Colluvium Scenario:** Analysis was performed based on the proposed reconstructed 3H:1V slope, with removal and replacement of the colluvial deposits by all new fill, provided by CWA and depicted in the cross-section.

Ideally, removal and replacement of the colluvial deposits would be performed with compacted fill, ultimately achieving a final 3H:1V slope extending to the head scarp. Our analysis indicates a FS of 1.4 would be achievable in this case. However, we anticipate that removal and replacement of all of the colluvial material would be logically difficult based on site constraints, and therefore would be cost prohibitive. We also anticipate that removal and replacement would expose the base of the head scarp with an increased likelihood of failure during the repair period.
