MEMORANDUM

RE: Technical Memorandum for Conceptual Stream Restoration of Wolf Creek in Goode Park

Restoration of Wolf Creek at Goode Park

Photo Log

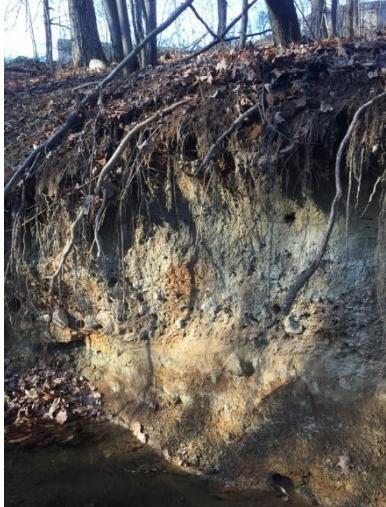
Photo 1A. Eroding bank (right bank) along Wolf Creek - rated as an "Extreme" BEHI.

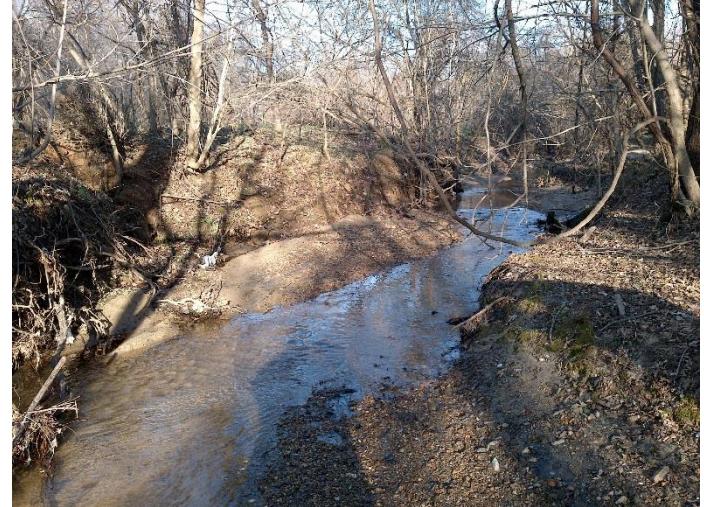
Photo 2A. Eroding bank (left bank) - rated as a "Very High" BEHI.

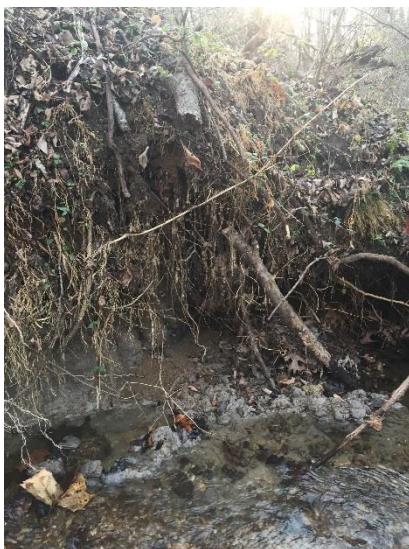
Photo 3A. Eroding bank on the left side near Wolf Creek Greenway - rated as a "High" BEHI.

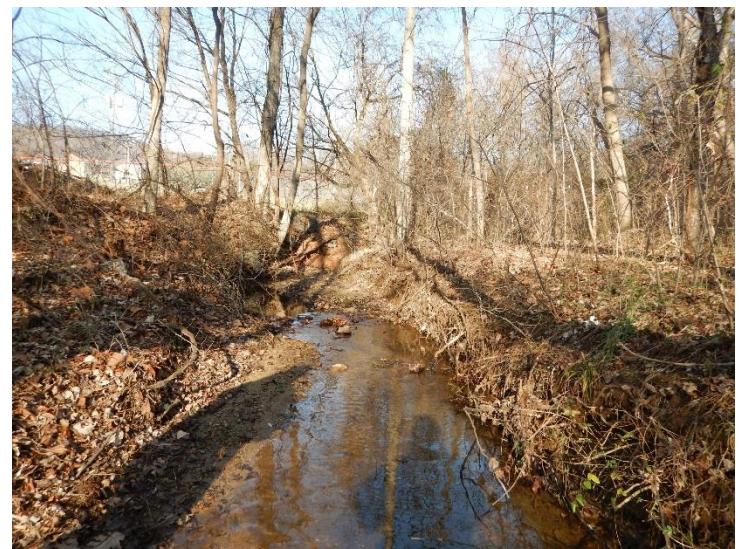
Photo 4A. Looking upstream at bankfull bench both sides of channel – rated as a "Moderate" BEHI.

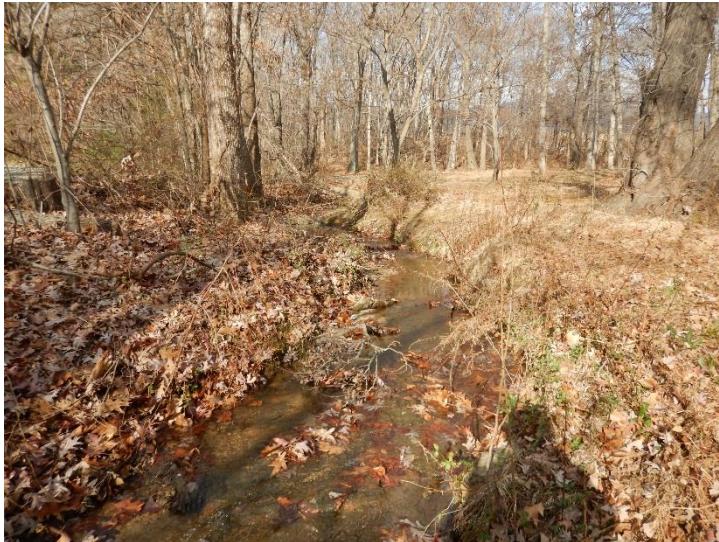
Photo 5A. Looking upstream along Wolf Creek - rated as a "Low" BEHI.

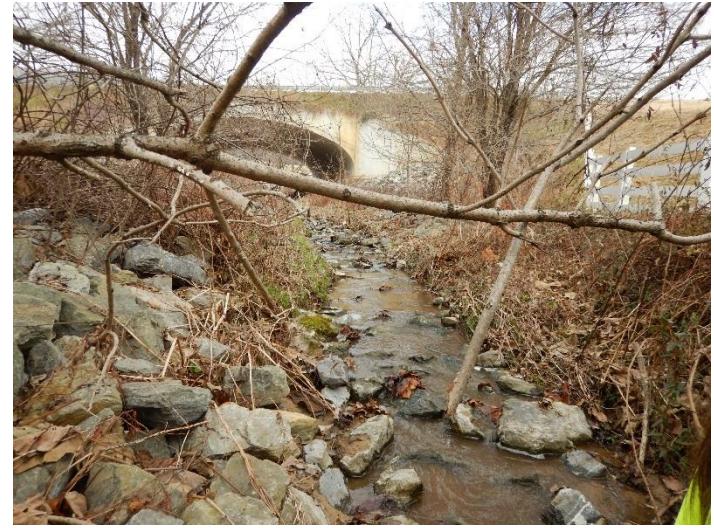
Photo 6A. Looking upstream along Wolf Creek – rated as a "Very Low" BEHI.

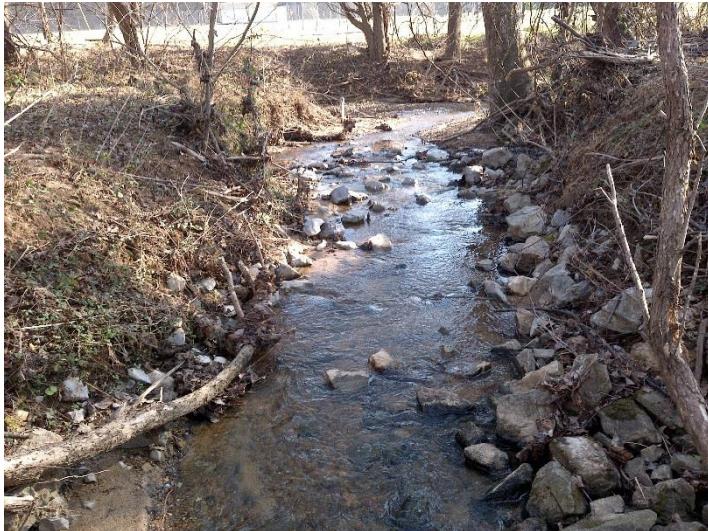
Photo 1. "Moderate" left and right bank from approximately Station 10+00. Minimal work needed, potentially a rock toe along left bank in meander to help stabilize (see Sheet 1 of Conceptual Drawings).

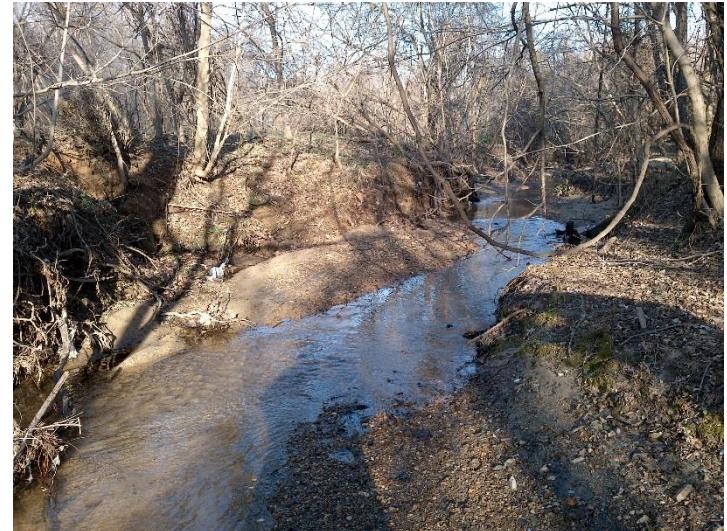
Photo 2. "Very High" erosion along the left bank around Station 14+00. Install toe wood to provide slope stabilization. Grade back right bank and install bankfull bench, line with coir matting and vegetate (see Sheet 1 of Conceptual Drawings).

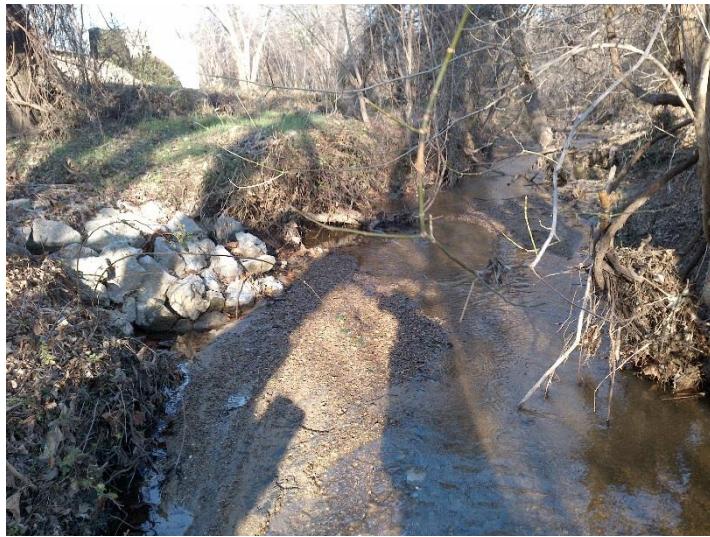
Photo 3. "Extreme" right bank (looking upstream) with severe sediment deposition at approximately Station 15+50. Grade back bank and install a bankfull bench. Install toe wood and reshape channel to centralize (see Sheet 2 of Conceptual Drawings).

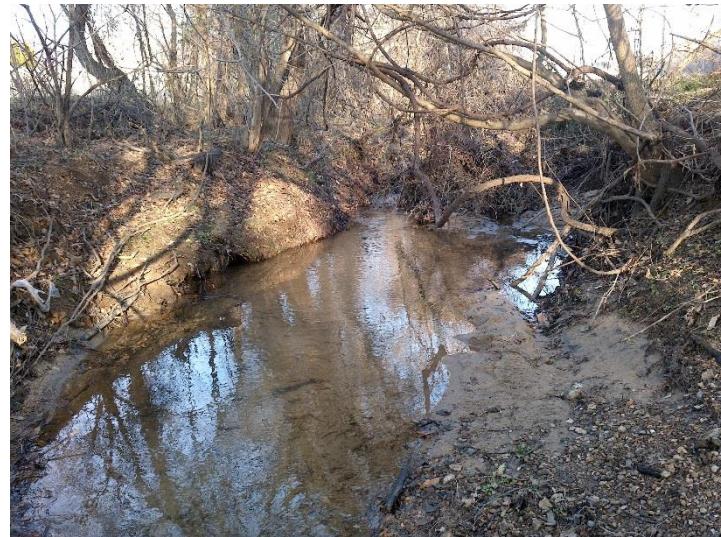
Photo 4. "High" erosion along the right bank and "Very High" along left bank around Station 17+00. Grade back both banks and install bankfull bench. Install toe wood along right bank in the bend to provide slope stabilization (see Sheet 2 of Conceptual Drawings).

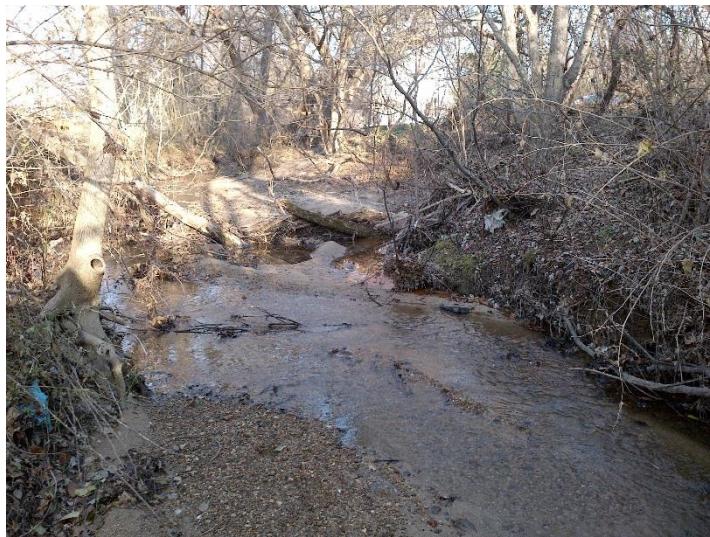
Photo 5. "High" left bank at approximately Station 19+00. Grade back bank and install toe wood for slope stabilization. Install rock cross-vane downstream for channel grade control (see Sheet 2 of Conceptual Drawings).

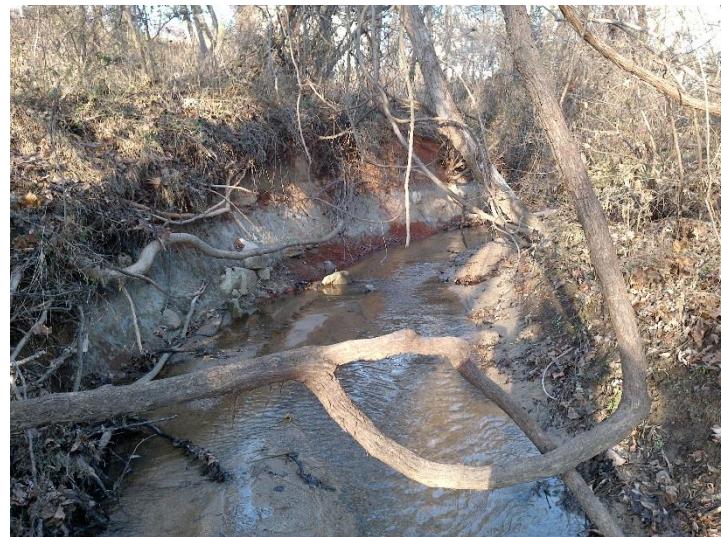
Photo 6. "Extreme" erosion along the right bank around Station 21+50 (looking upstream). Grade back right bank and install bankfull bench, line with coir matting and vegetate (see Sheet 2 of Conceptual Drawings).

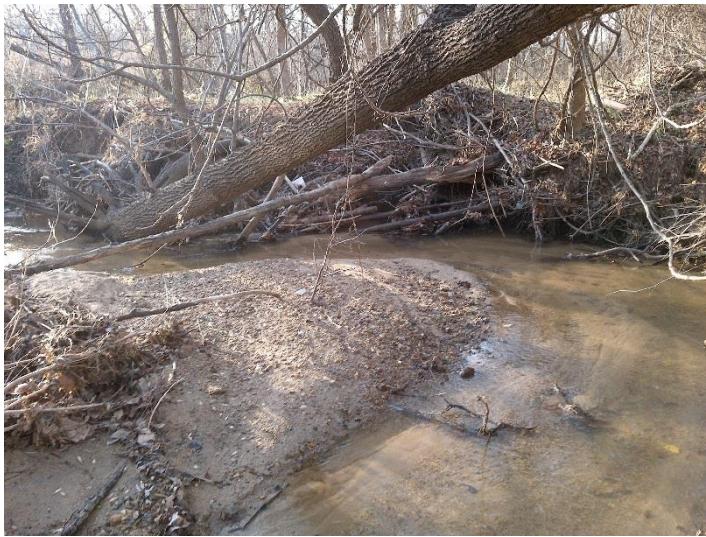
Photo 7. "Very High" left bank with severe sediment deposition at approximately Station 23+00. Grade back bank and install a bankfull bench. Install rock toe and reshape channel to centralize (see Sheet 2 of Conceptual Drawings).

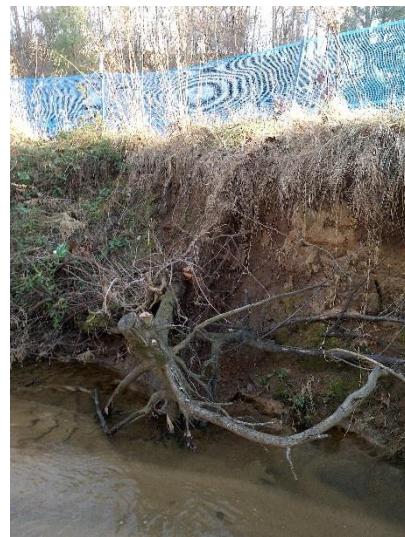
Photo 8. "High" erosion along the left bank close to the Wolf Creek Greenway around Station 23+50. Grade back bank and install bankfull bench. Install rock toe along bank in the bend to provide slope stabilization (see Sheet 3 of Conceptual Drawings).

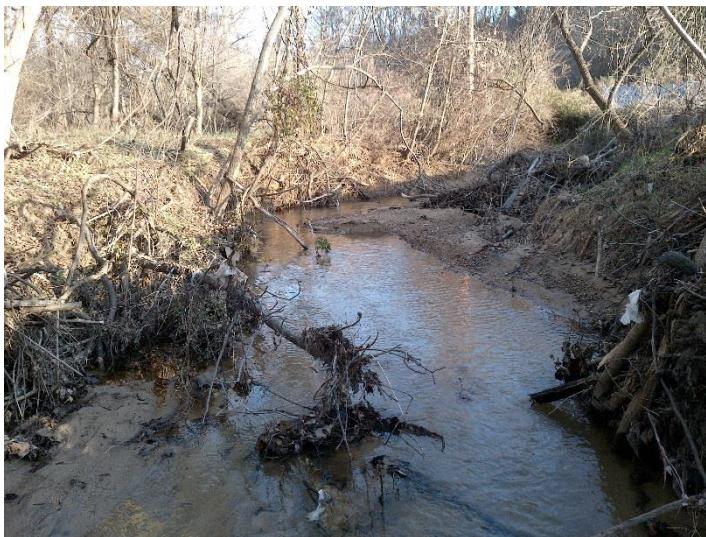
Photo 9. "Extreme" right bank at approximately Station 24+00. Install toe wood for slope stabilization along right bank. Grade back bank on left (see Sheet 3 of Conceptual Drawings).

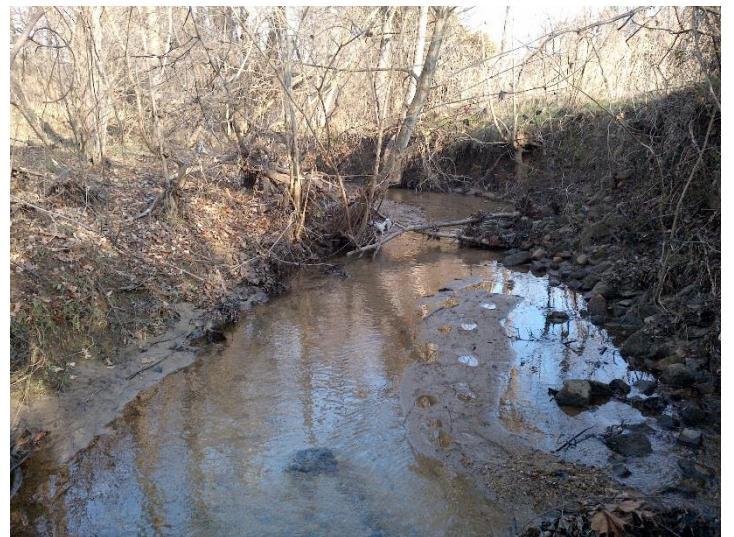
Photo 10. "Very High" erosion along the left bank and "High" erosion around Station 25+00 (looking downstream). Grade back both banks and install rock toe along the right bank. Use local material when possible (see Sheet 3 of Conceptual Drawings).
