RE: Dixie Caverns Monofill for Stabilized Soil and Sediment; Post-Closure Inspection;
CHA Project Number 067846.000

POST-CLOSURE INSPECTION
Dixie Caverns Monofill

SITE PHOTOGRAPHS
Dixie Caverns Monofill
Post-Closure Inspection
June 26, 2023

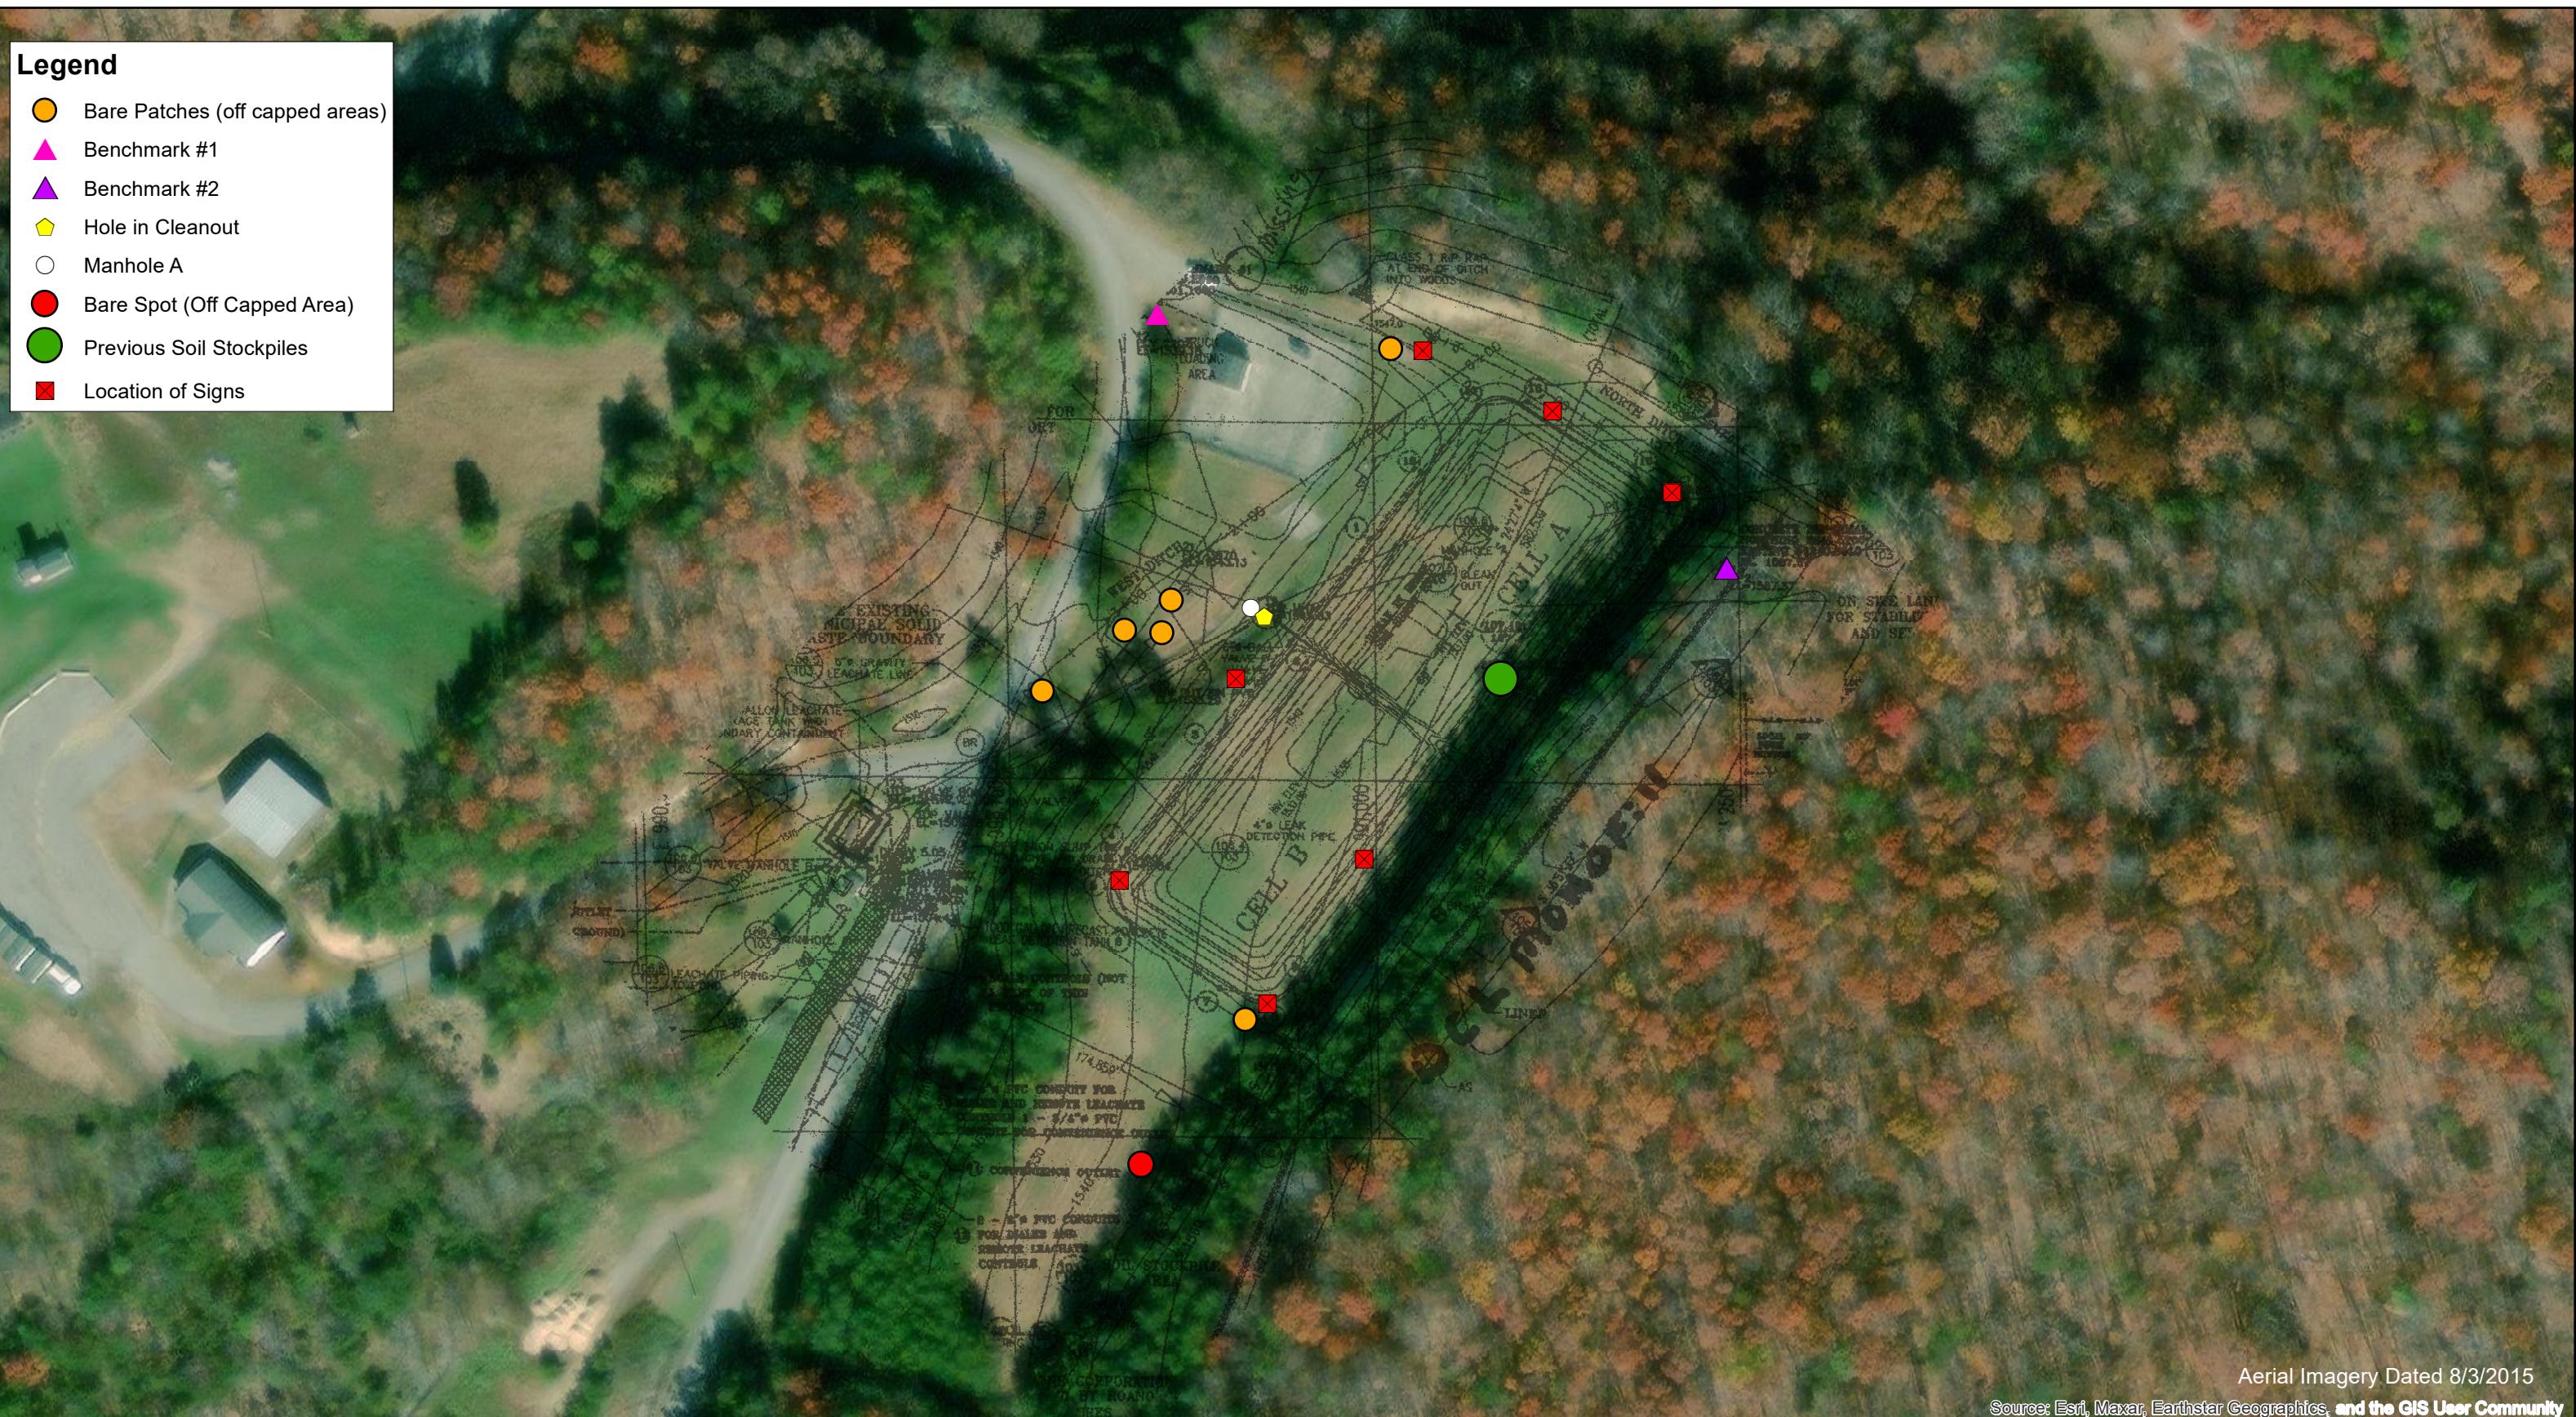
Date: June 26, 2023
Performed By: Raylani Reis
SHEET 1

1. Bare areas and small patches noted off of the capped areas near the access road surrounding the West Ditch as shown as orange circles on the site map;
2. Patches located at the end of the gravel entrance road adjacent to Cell A; and
3. Bare area noted off of the capped areas south of Cell B where previous staging area was located when the cell was being constructed (shown as a red circle on the site map).

The attached map shows the locations of these areas of thin vegetation that were noted during the June 2023 inspection.

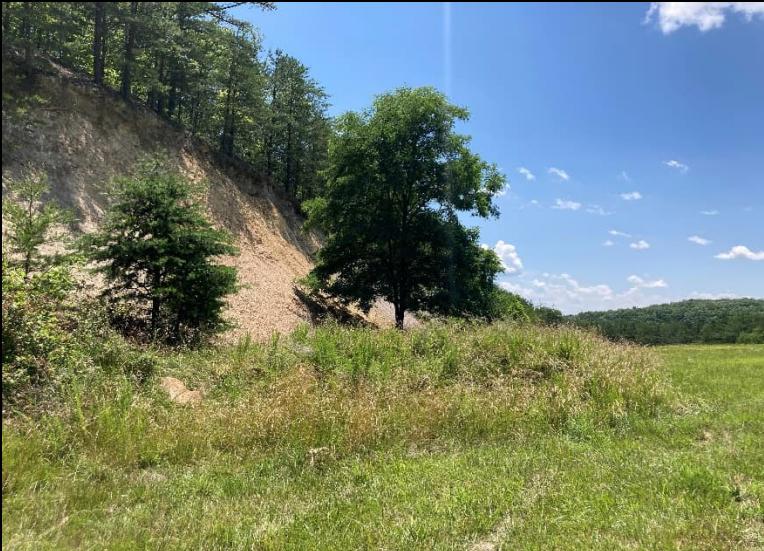
1. As noted in previous quarterly reports, the monofill was used to store soil on the east side of Cell A, adjacent to the bank as initially noted during the August 9, 2010 quarterly inspection. Vegetative cover continues to improve where stockpiled soil was once stored (Photograph 4 on Photo Log).

2. The shrubs/black locust trees previously located on top of the area where previous soil stockpiles were stored are no longer present (Photograph 4 on Photo Log).

Photograph 4. Cell A – Area of Former Soil Stockpile.

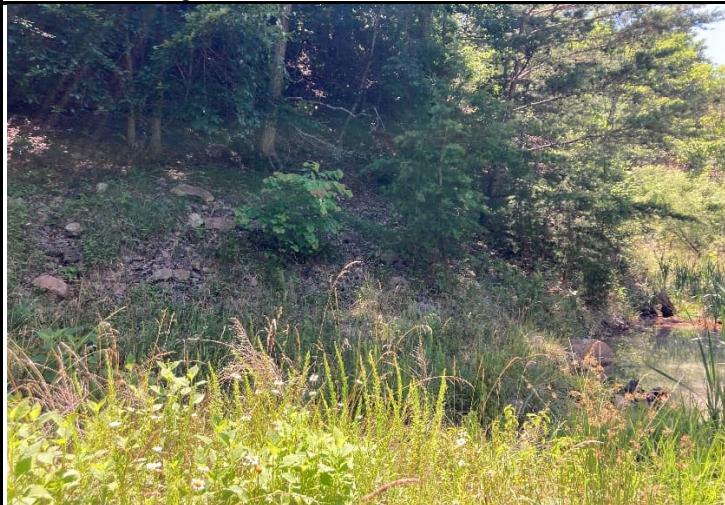
The surrounding area where a five-cubic-yard pocket of fly ash is securely buried underneath 7-feet of clay on the south bank (Photograph 17) of the sediment basin located in the ravine on the northern part of property was assessed during the June 2023 inspection. Additionally, the sediment basin drop inlet (Photograph 19) and associated piping near manhole access (Photograph 20) and at the terminal end of piping were inspected (Photographs 21). There was no evidence of erosion or displacement of soil in this area and all visible conveyance lines diverting the stream around the pocket of fly ash were free of debris and obstructions. As noted during the December 2022 inspection that there may be a small crack in the terminal end of the corrugated piping that discharges to the creek. However, the flow observed during the June 2023 inspection was significant enough that the flow exited the pipe and the extent of the small crack could not be fully determined due to the increased volume and small amount of organic debris that was present where the previous crack was observed (Photograph 21). However, this crack that was observed does not impact the pocket of fly ash and it remains securely entombed in the earthen dam and this area will continue to be monitored during future post-closure inspections.

Photograph 17. Location of Pocket of Fly Ash-contaminated Sediment (Looking West).

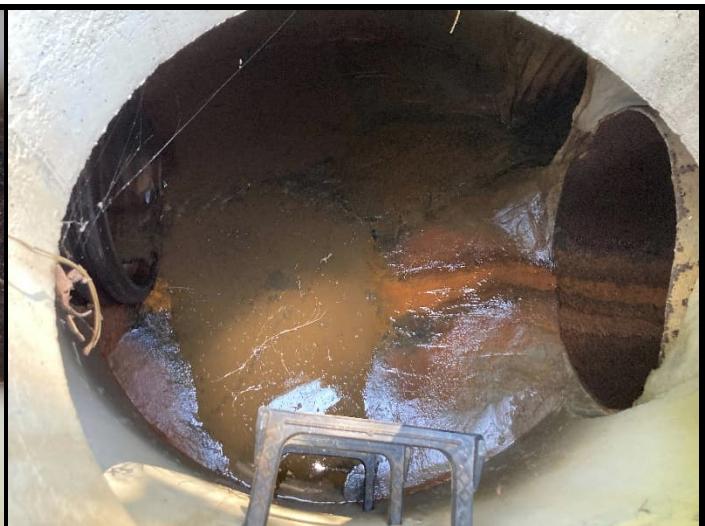
4. Bare patches that were observed at the southeast corner of Cell B during previous inspection were no longer present (Photograph 9 on Photo Log).
5. A small crack that was observed during the previous inspection remains in the terminal end of the corrugated piping that discharges to the creek that bypasses buried fly ash, no threat to integrity due to the location of the crack (Photographs 20-22 on Photo Log).

Photograph 20. Conveyance Lines Diverting Stream around Buried Fly Ash.

1. Continue to monitor terminal end of piping that diverts stream around buried fly ash for any undermining of soil underneath piping.

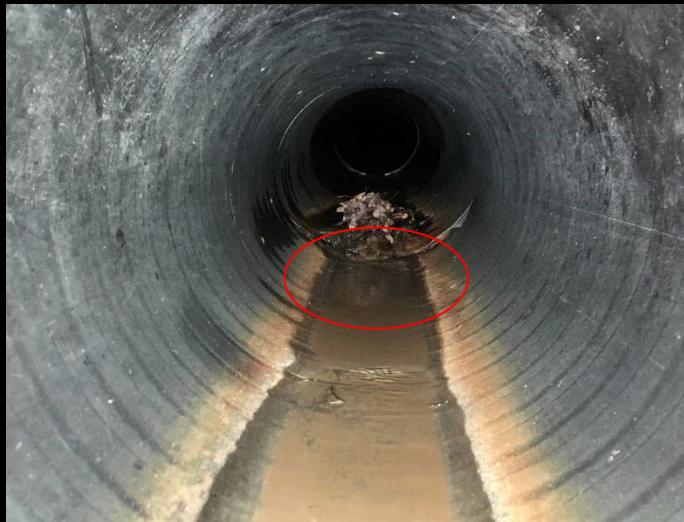
Photograph 21. Terminal End of Piping Diverting Stream Around Buried Fly Ash – Possible Crack at end of Plastic Corrugated Piping (Looking South).

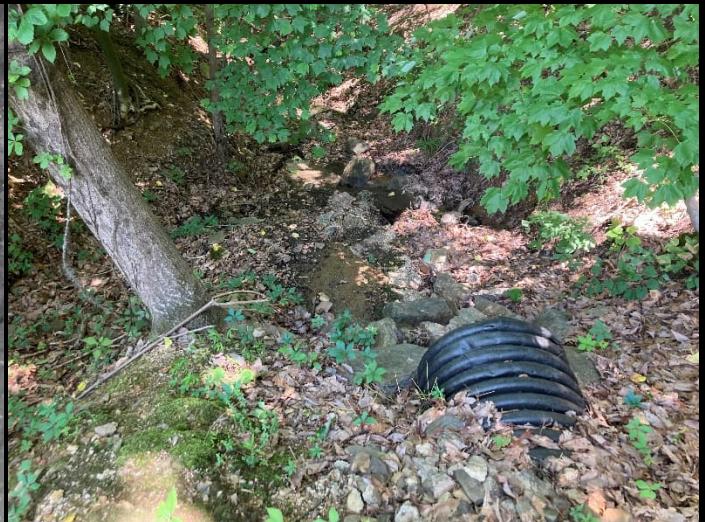
Photograph 22. Drainage from Piping Diverting Stream Around Buried Fly Ash (Looking South)

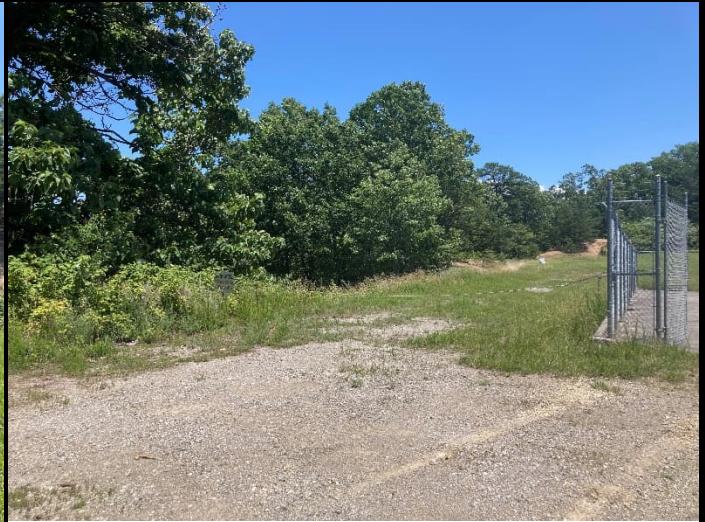
6. The wire cable to restrict vehicular traffic onto the capped area of the monofill was secure (Photograph 24 on Photo Log).
7. The shrub in the West Drainage Ditch off of the side slope of Cell B has been removed since the previous inspection (Photograph 25 on Photo Log).

Photograph 24. Secured Wire Cable Preventing Access to Capped Area.

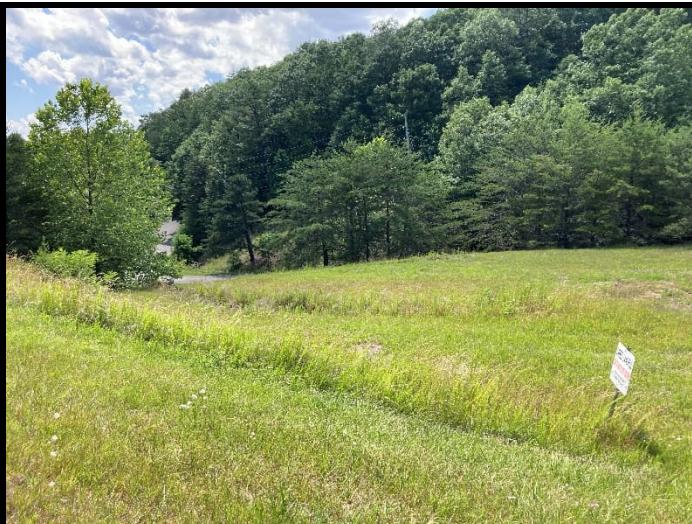
Photograph 25. West Drainage Ditch Looking West

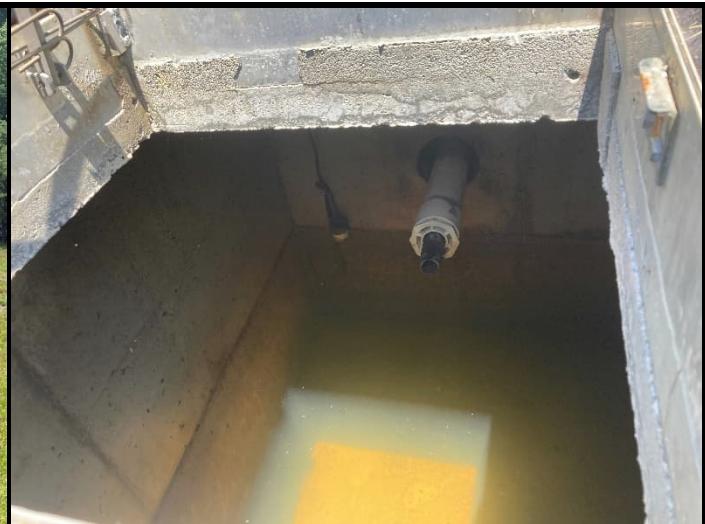
3. The pH of the upper leak detection tank was measured at 7.30 S.U. compared to 6.88 S.U. during the previous inspection. CHA Consulting, Inc. will continue to monitor the pH at the upper leak detection tank during future inspections.

Photograph 26. Leak Detection Tank.

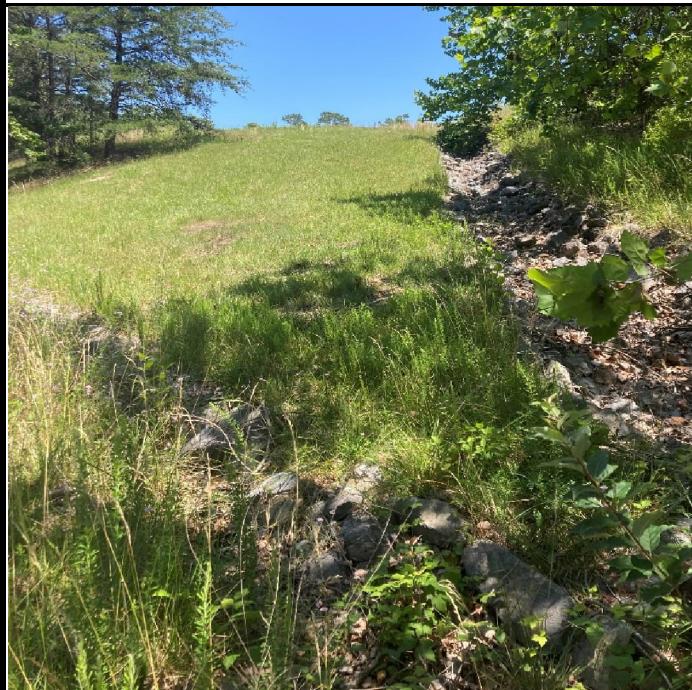
Photograph 27. Small patches near West Drainage Ditch (Looking Northeast).

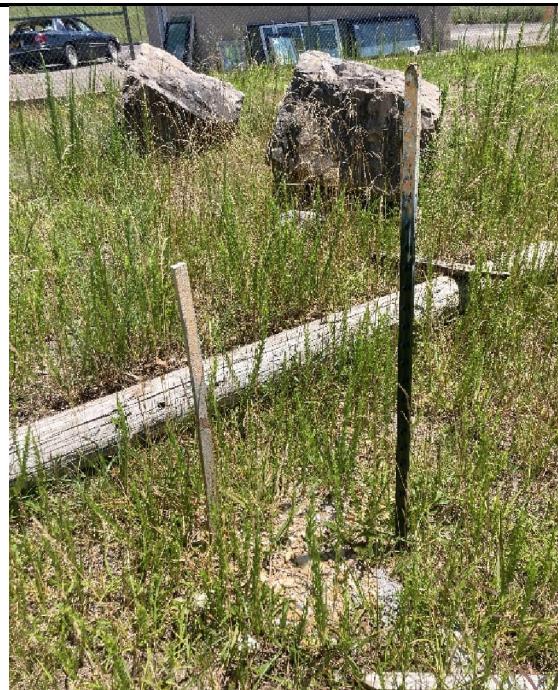
Photograph 28. Benchmark #1

8. Benchmark #1 has been replaced (Photograph 28) and is located near the two large boulders by the gravel entrance that leads to capped area.
