**ATTACHMENT TO ANNUAL INSPECTION REPORT FOR WOODS END DAM  
(INVENTORY 161005), PICTURES TAKEN FEBRUARY 14, 2024**

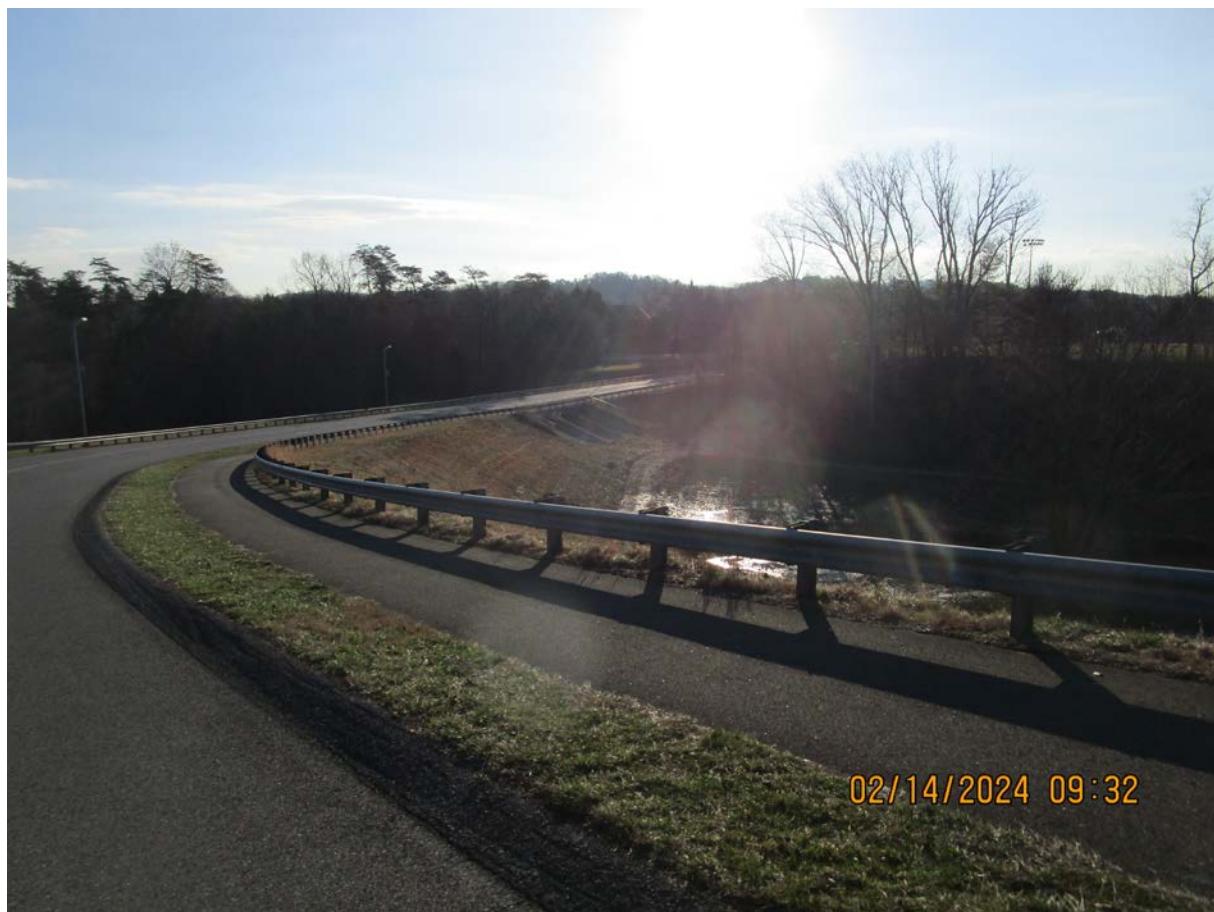
View across Dam, Looking South showing Upstream Dam Face and Emergency Spillway Pipes

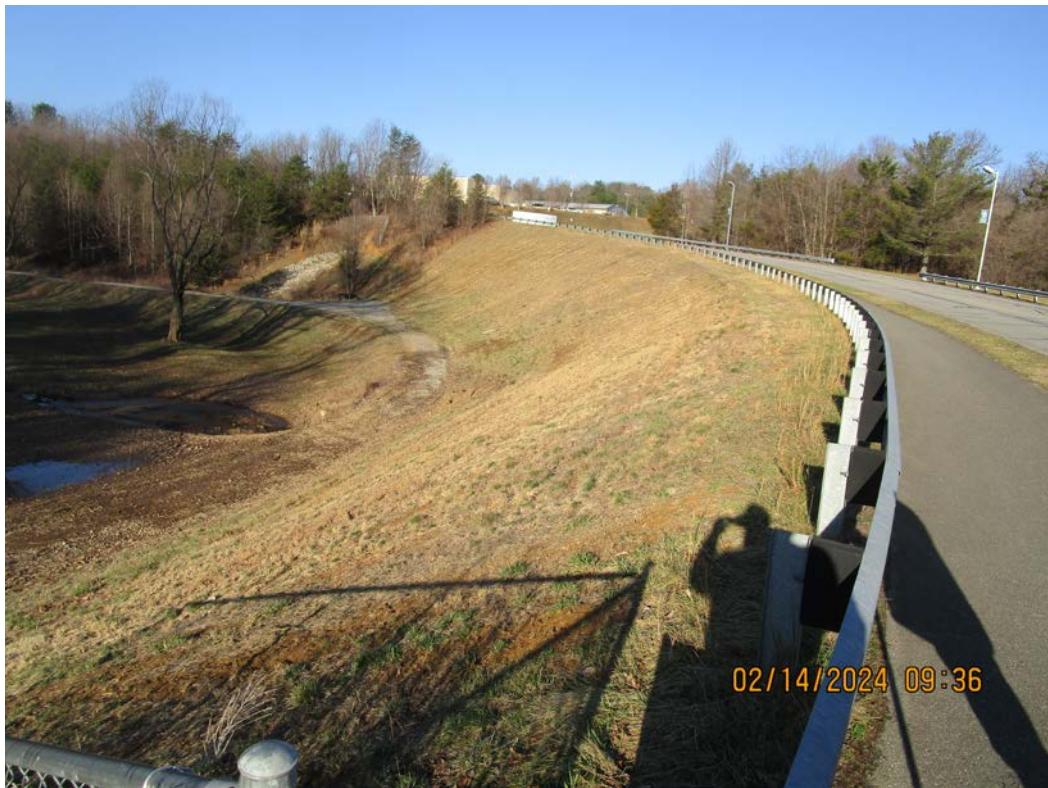
View across Dam, Looking North showing Upstream Dam Face

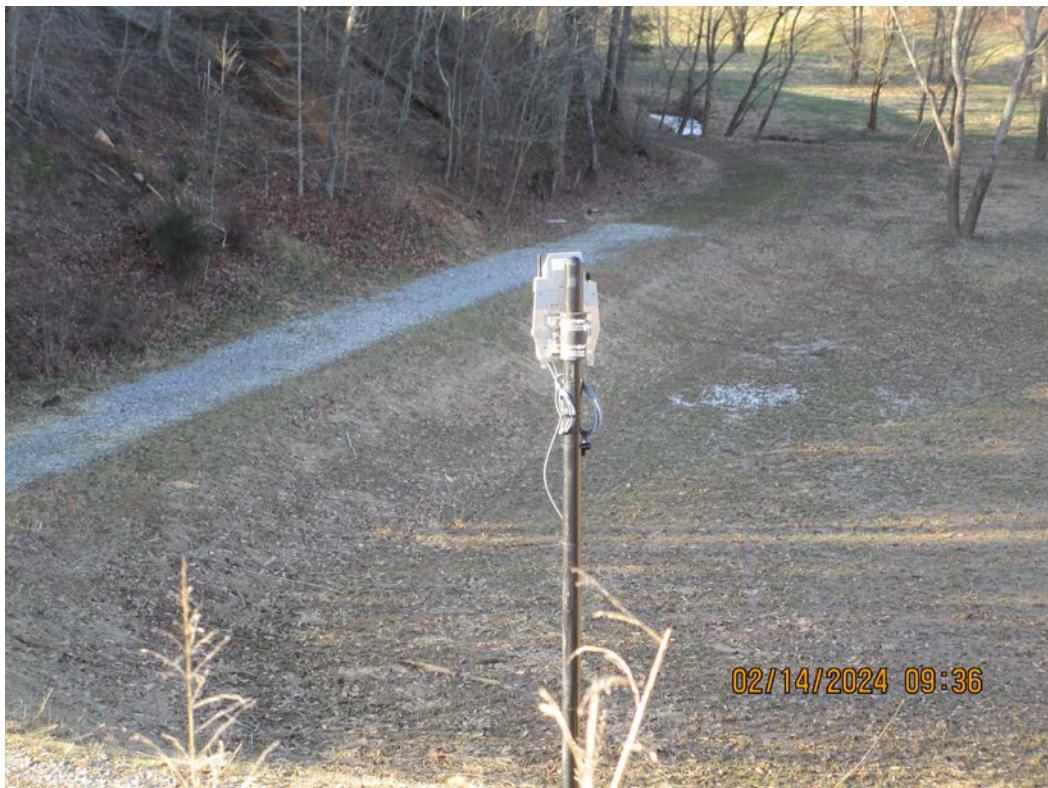
High Water Monitor with Cell Communications and Solar Power

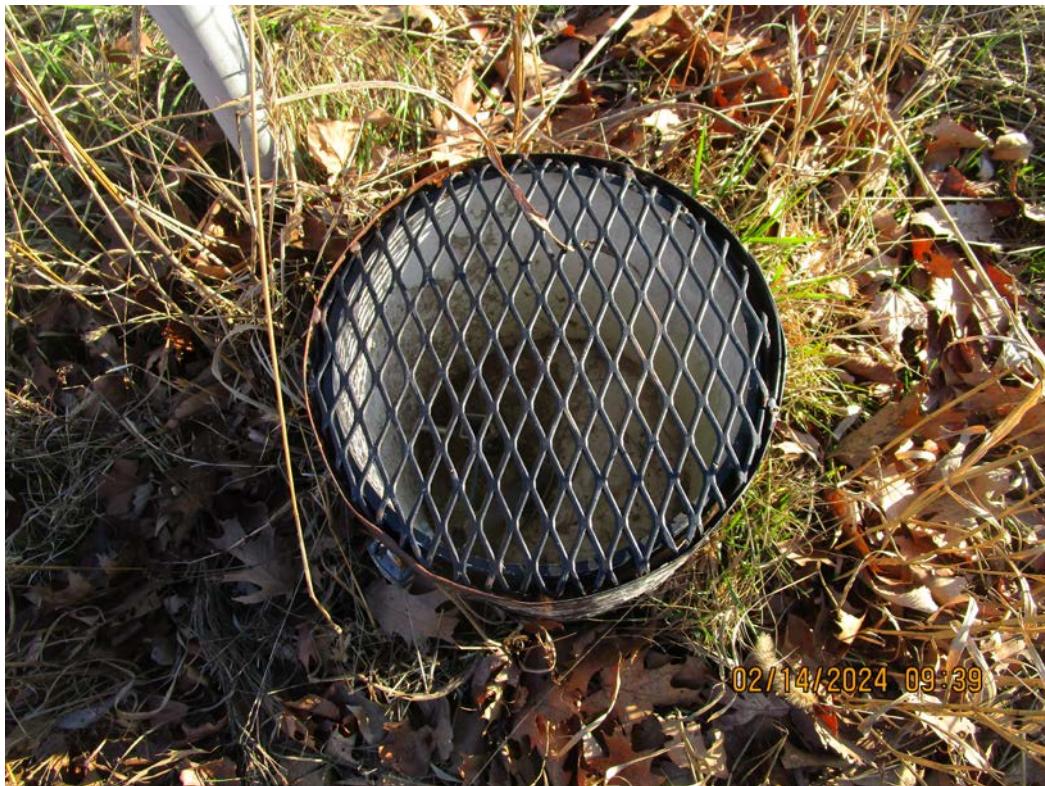
Stillwell w/ Pressure Transducer for High-Water Monitoring/Alert System

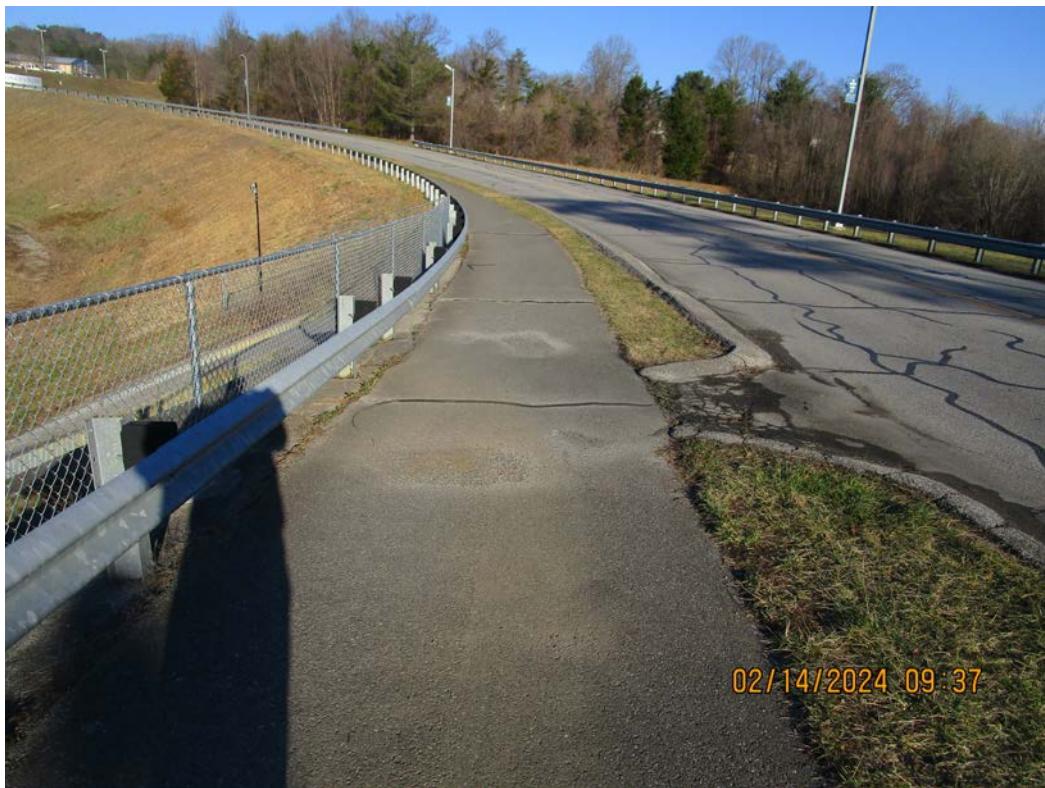
Looking overtop of Emergency Spillway Culverts, Note Settlement to Asphalt Trail

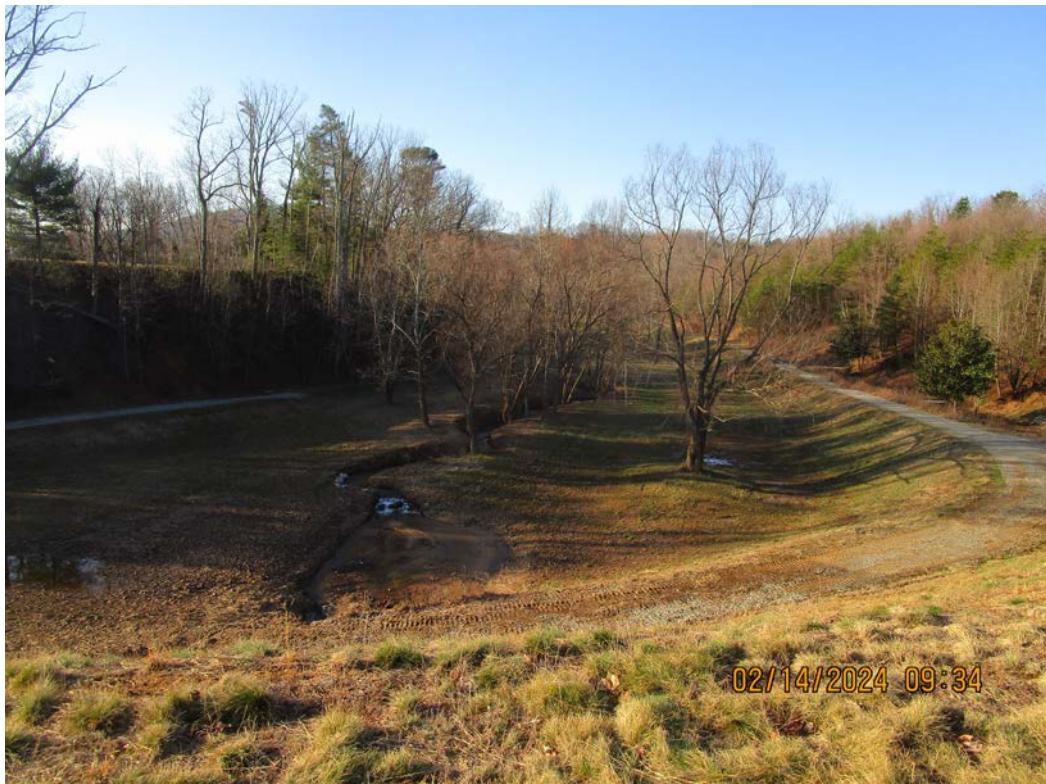
Looking u/s from top of Dam over Principal Spillway. Principal Spillway is not Visible

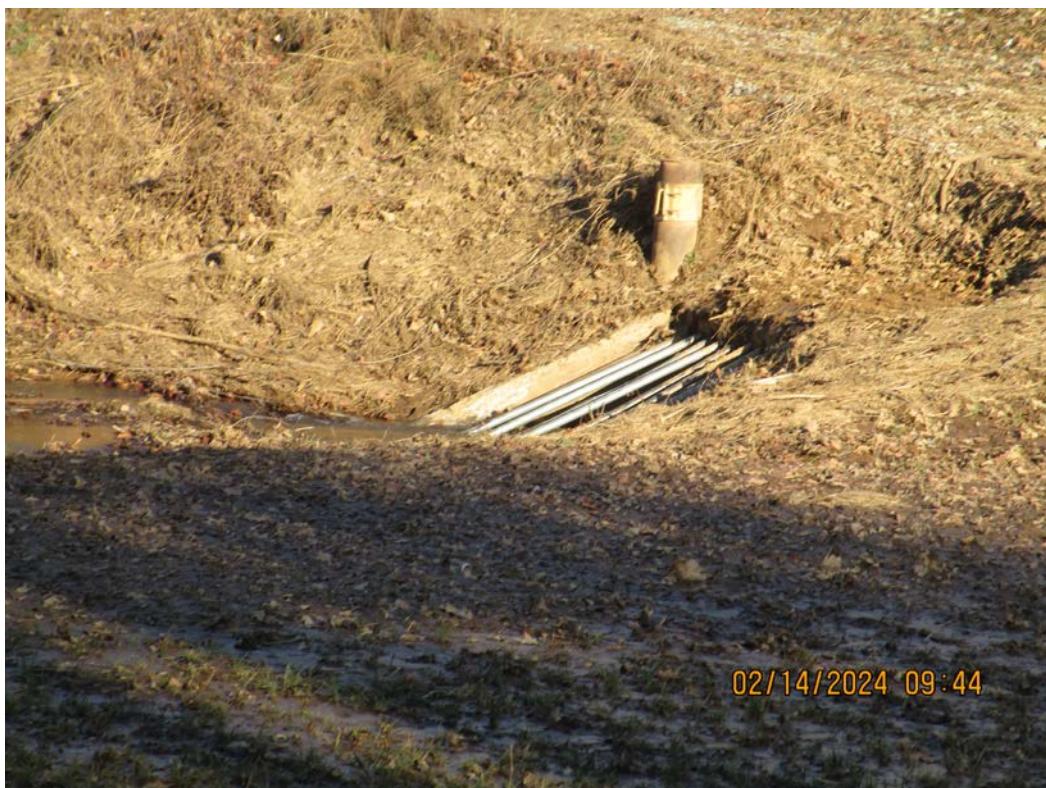
Intake structure. Note inlet is clear, with no debris.

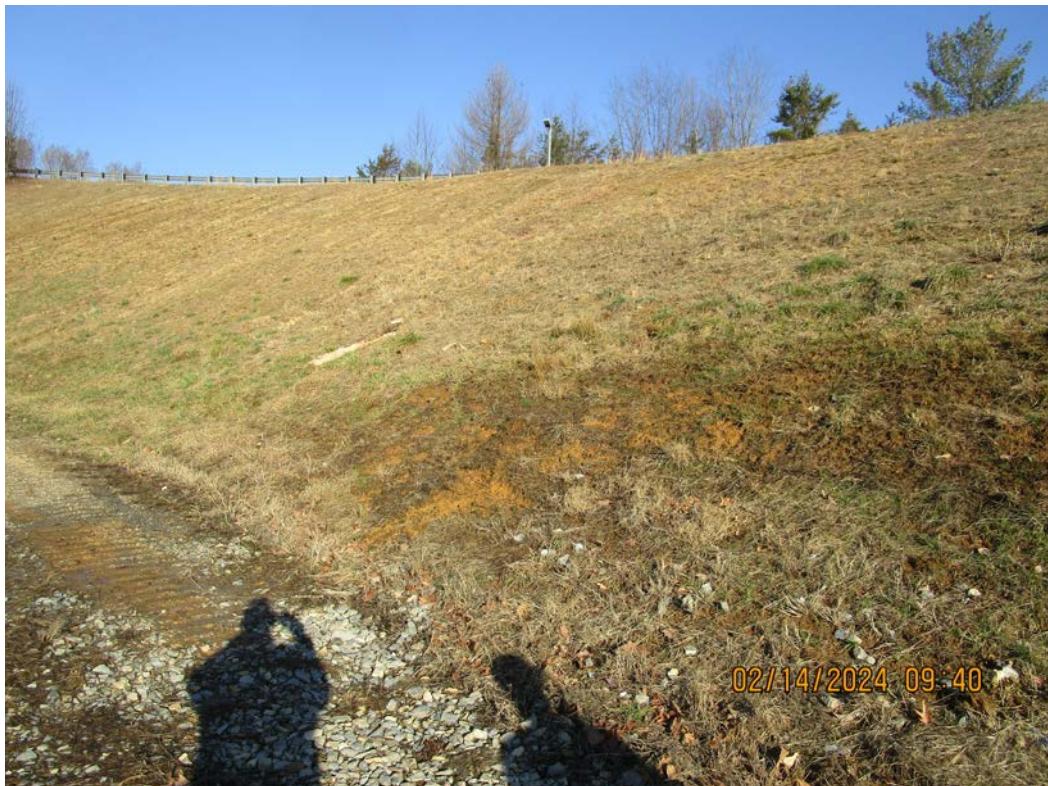
Looking at Upstream Dam Face, toward North Abutment- slight seep noted

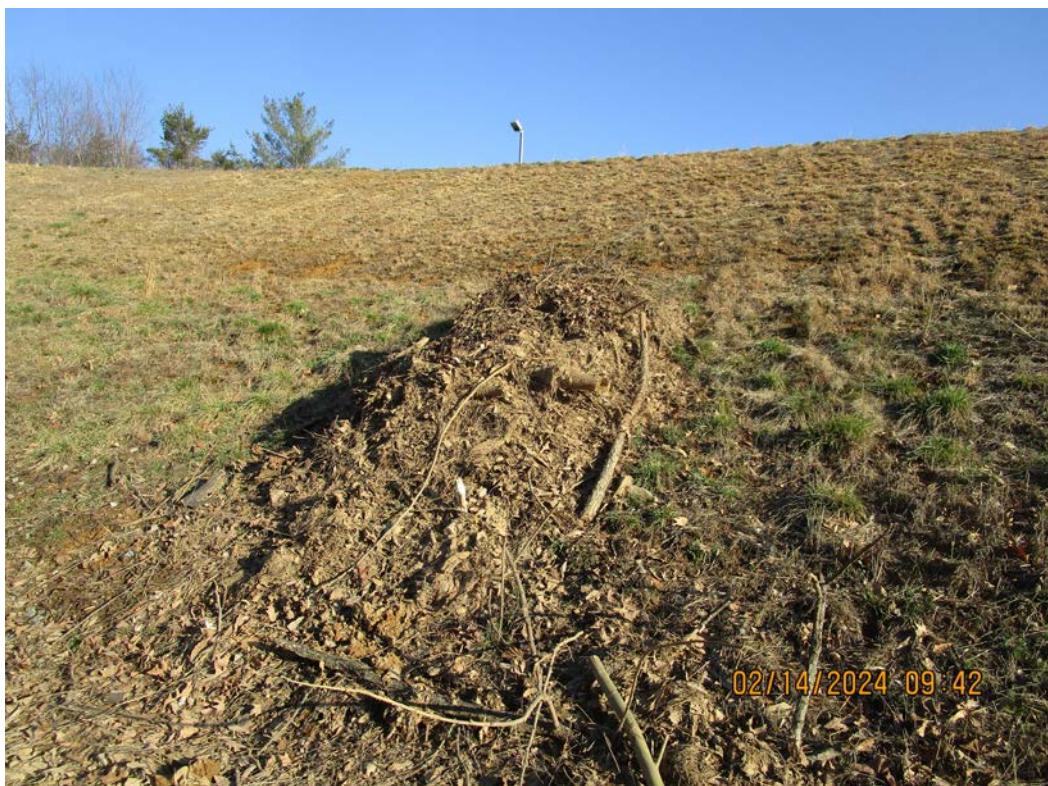
Minor debris on Upstream Dam Face

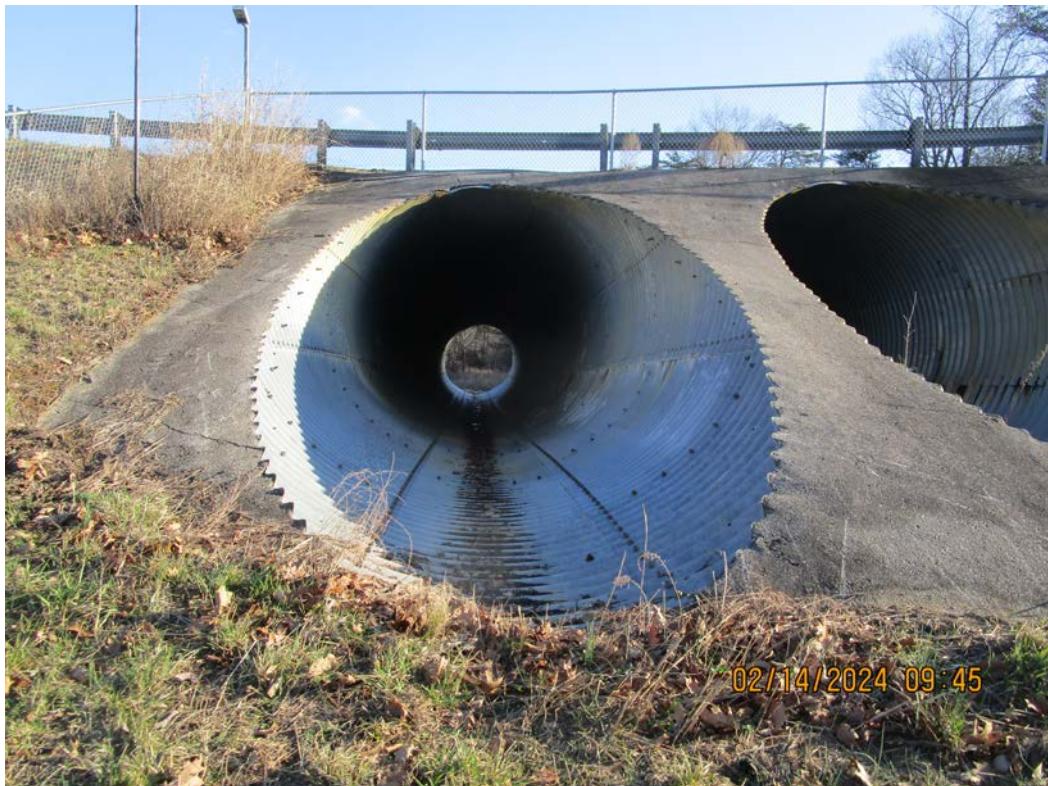
Looking Downstream in Left (North) Culvert

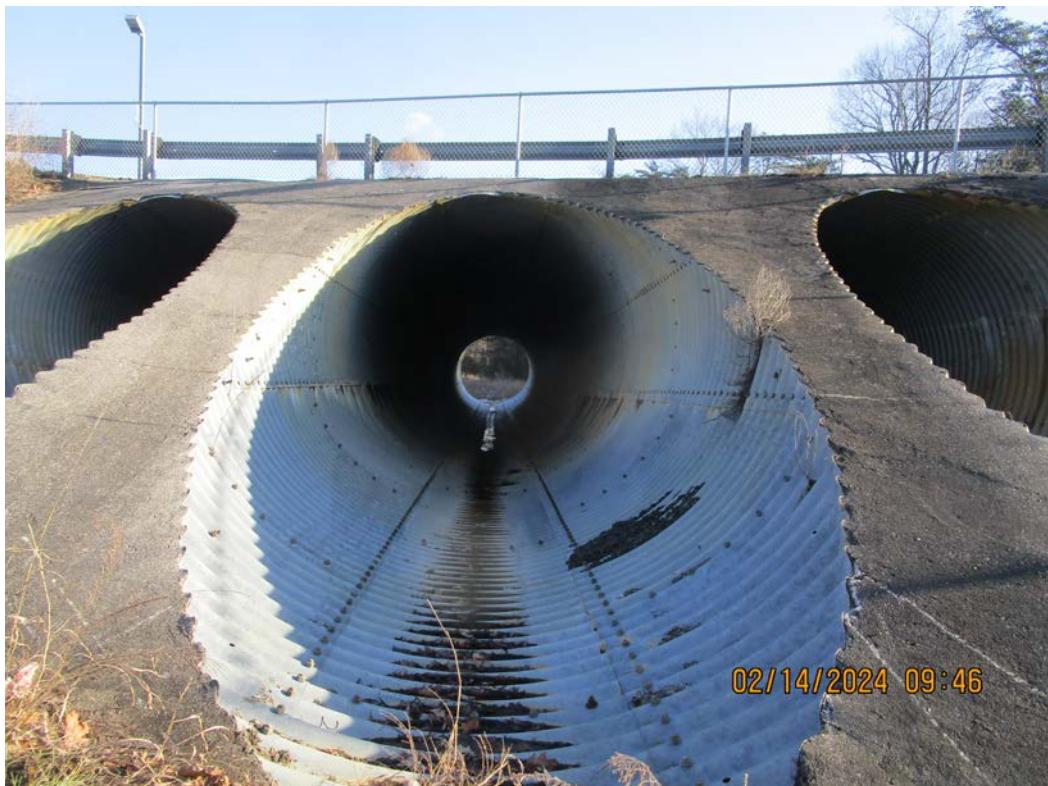
Looking Downstream in Center Culvert

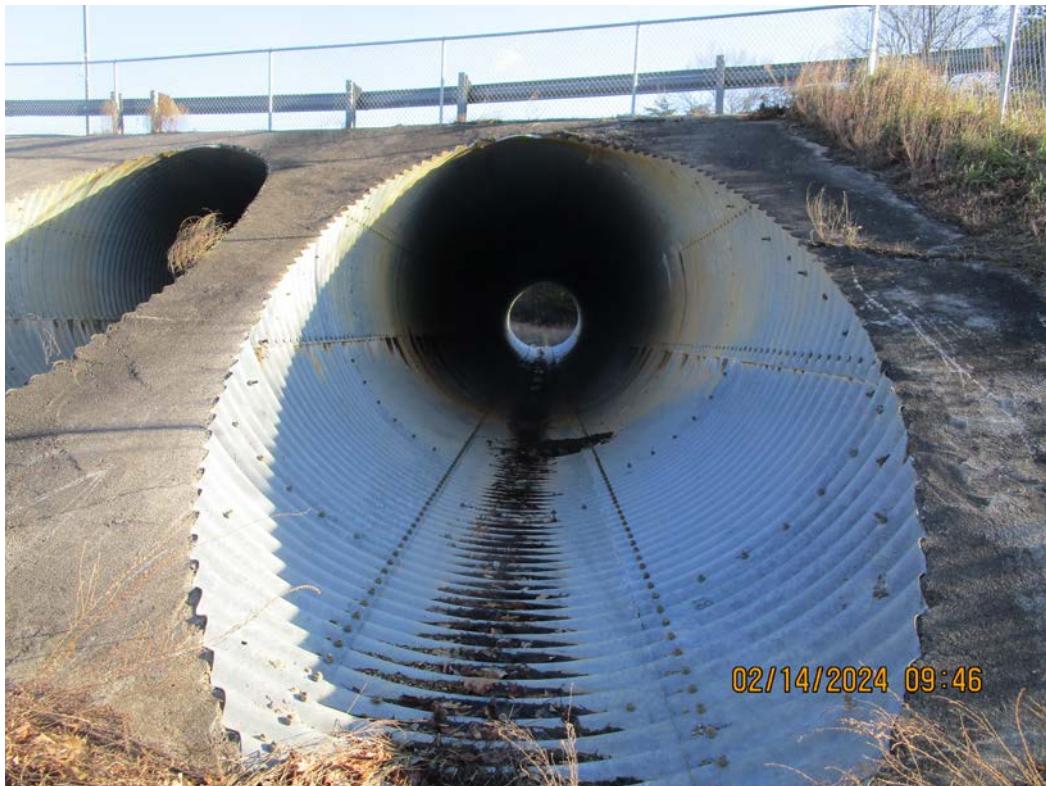
Looking Downstream in Right (South) Culvert

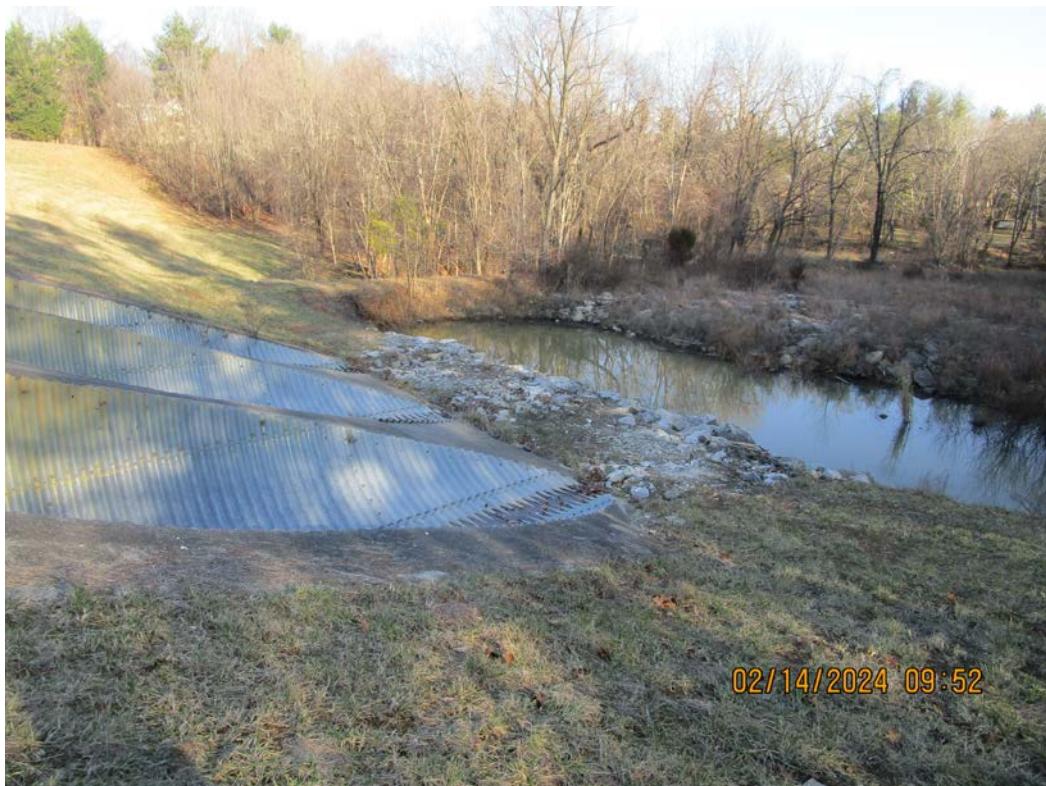
Plunge pool at emergency spillway outlet.

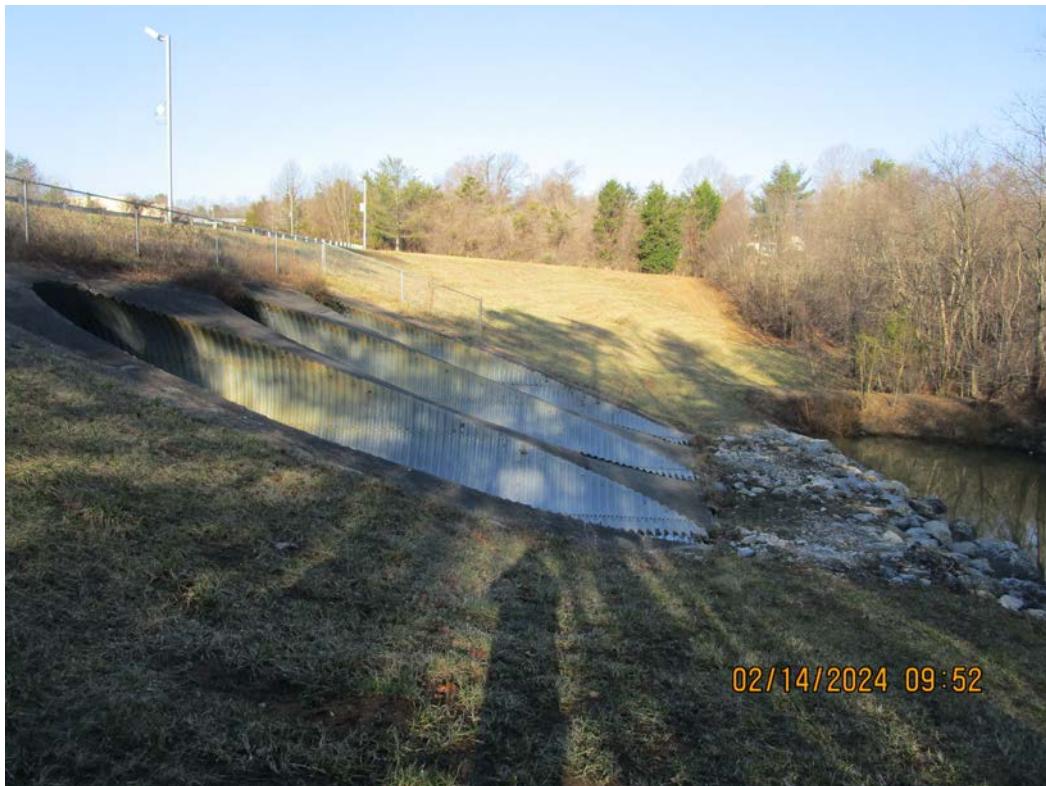
Downstream Face of Dam

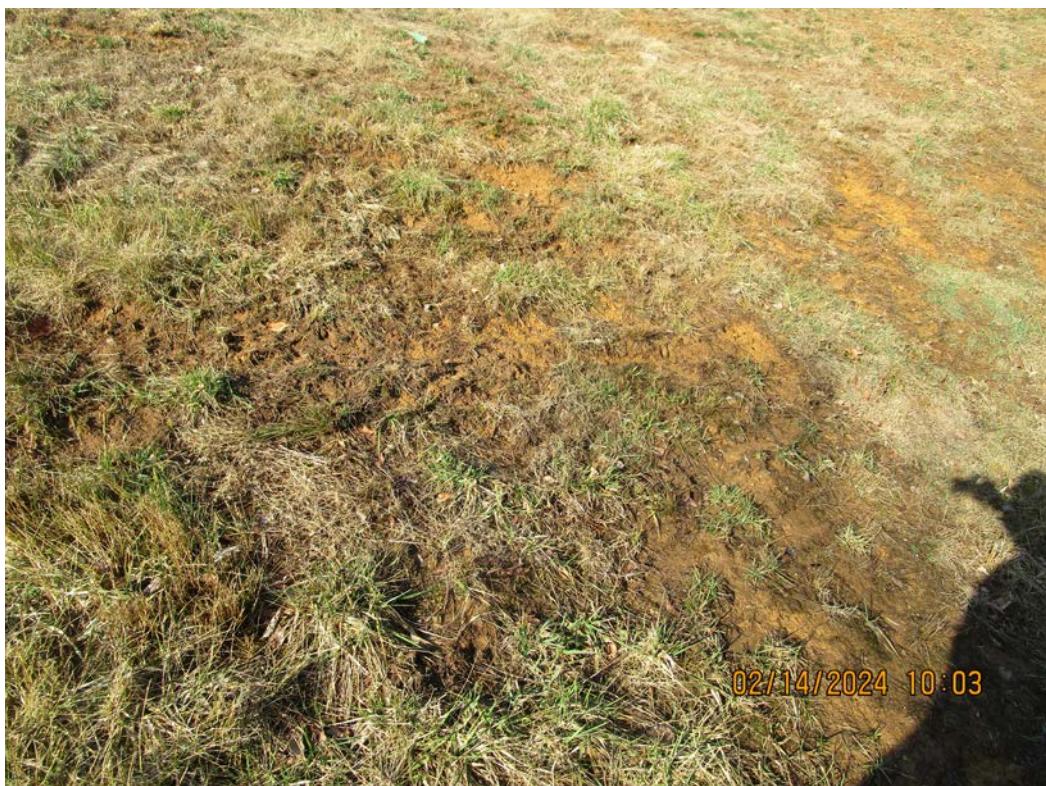
Downstream Face of Dam, Moist Seep Area

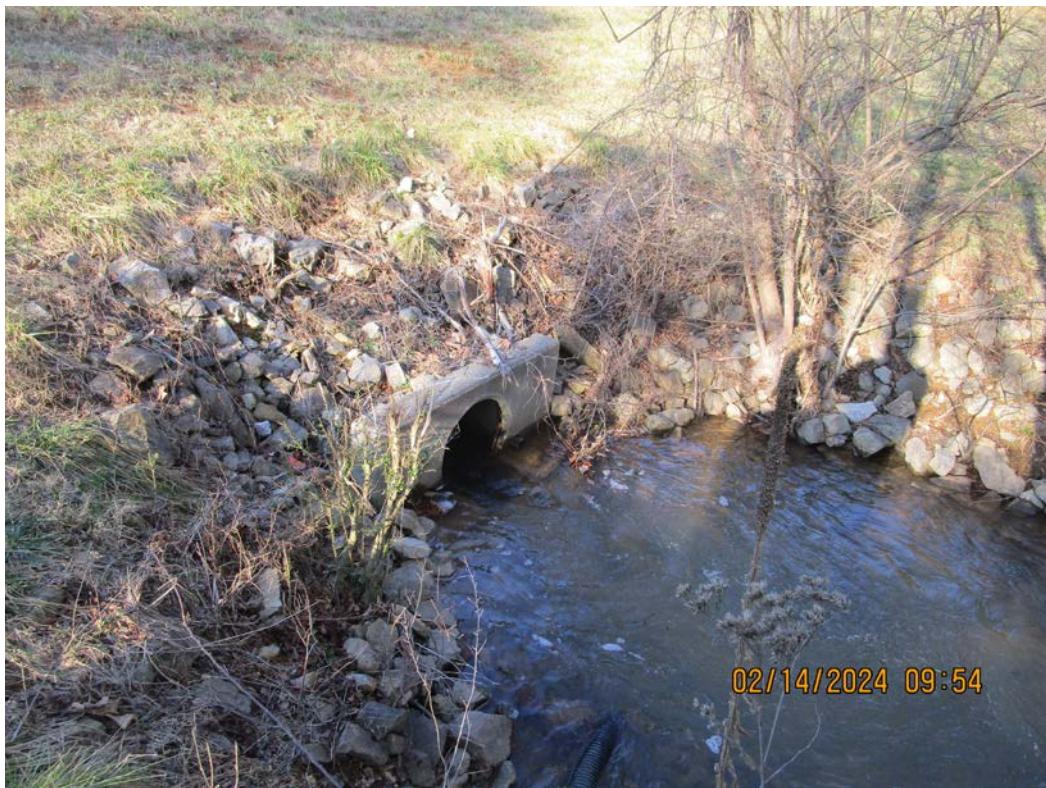
Looking Upstream at Discharge from Principal Spillway Pipe

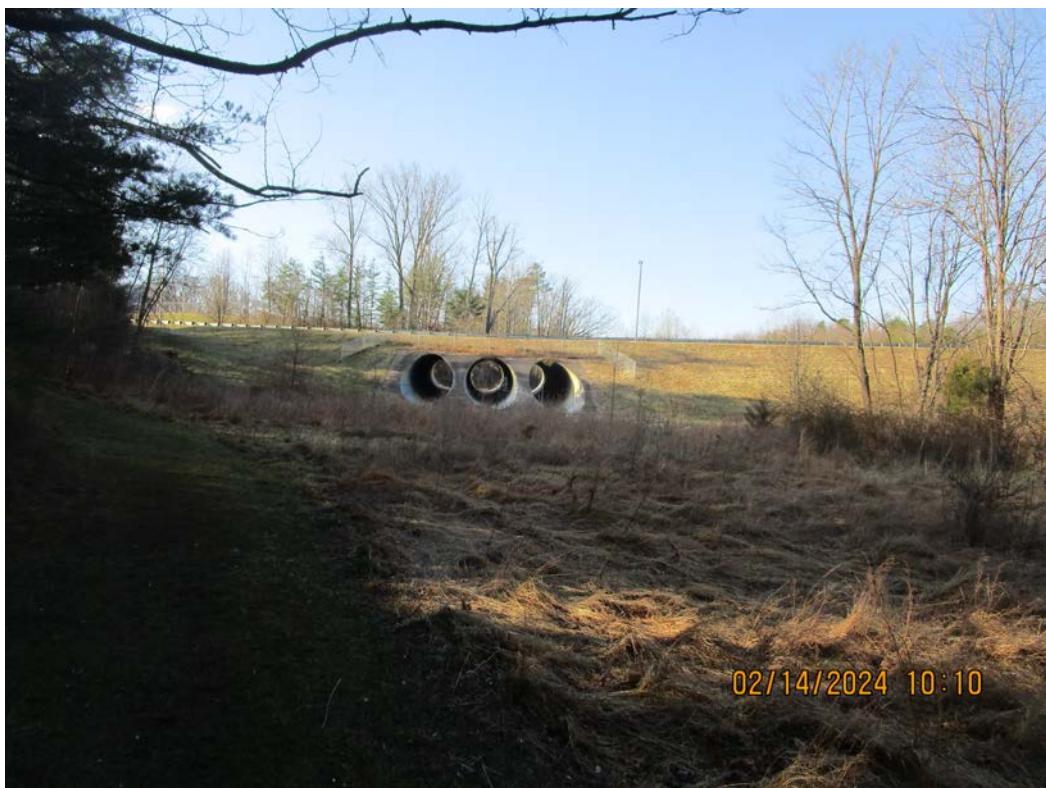
Looking Upstream at Dam Emergency Spillway Discharge Point

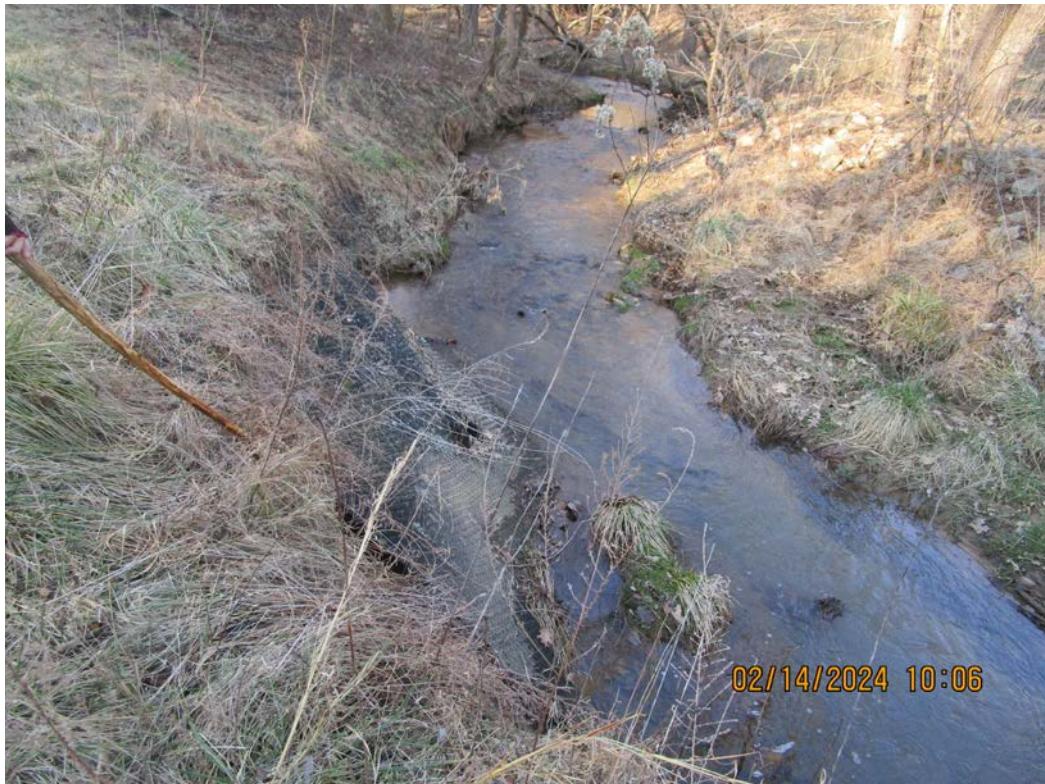
Damage to creek bank, downstream from dam, where storm flow from the Emergency Culverts flows back into the creek. No significant change since 2023 Inspection
